# Undercliffe

## Conservation Management Strategy

January 2024 | 23-378

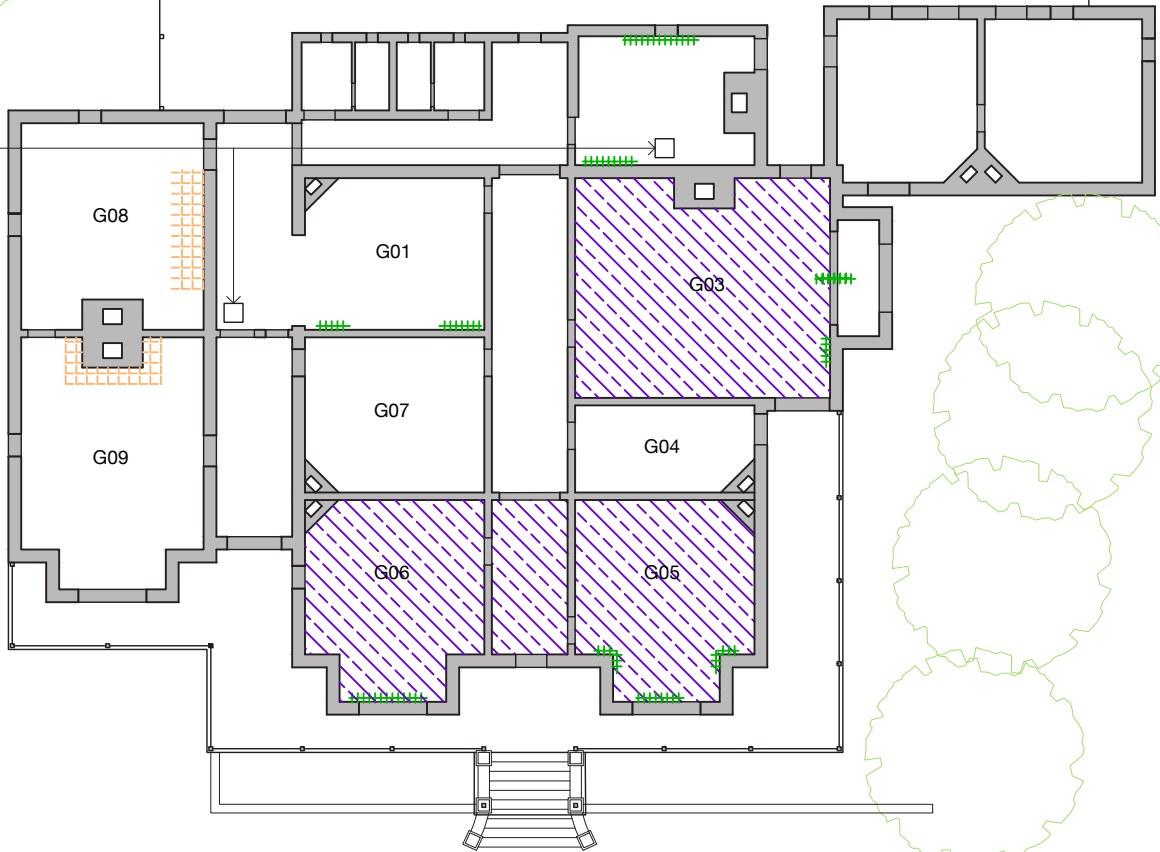
- CEILING CRACKING / CORNICE SEPARATION. REFIX AND REFINISH TO MATCH.
- RUSTING TO CEILINGS. BRUSH BACK CORROSION AND MAKE GOOD, PAINT BOTH FACES.
- CEILING DEFLECTION. REMEDIATE PIGEON INGRESS, CLEAR ROOFSpace DEBRIS, PROP AND MAKE GOOD.

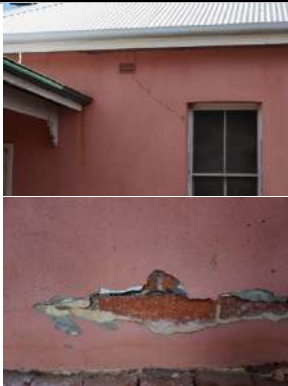
Low level brickwork decay noted to north east corner near known plumbing leak to adjacent garden bed. Deterioration appears to be isolated below visible DPC	Isolate and repair plumbing issues before undertaking like-for-like repairs to brickwork and pointing	10%	2	
Windows	Timber framed painted white. Four fixed panel obscured glazing windows to bathrooms, four double hung sash windows to other rooms	C – Fair	Paintwork to windows is worn but generally sound.	Repair where necessary to ensure windows are watertight. Remove paint that is loose and friable back to sound face to allow repainting. Prepare and repaint, with colour to match or based on paint scrape analysis of original finishes	8	3

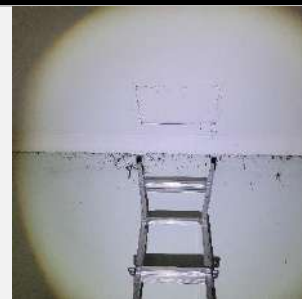
West Wall	Masonry wall	B	Dust entering from ceiling space on north wall suggesting separation of wall and ceiling lining.	Ensure cornice is in place after completion of required ceiling repairs.  Monitor for cracking throughout foundation injection works.	100%	1

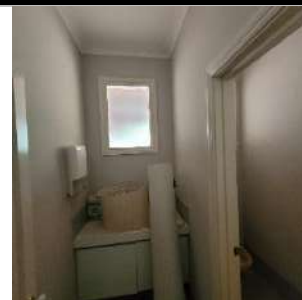
East Wall	Masonry wall	B	No significant visible structural defects	Monitor for cracking throughout foundation injection works.	100%	4

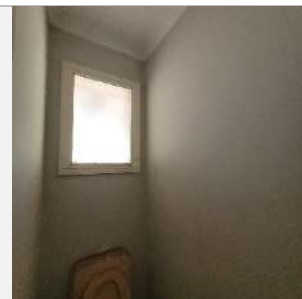
South Wall	Masonry wall	B	No significant visible structural defects	Monitor for cracking throughout foundation injection works.	100%	4	
West Wall	Masonry wall	B	No significant visible structural defects	Monitor for cracking throughout foundation injection works.	100%	4
