# Helena Valley Urban Precinct

## Environmental Assessment Report

A25.232\_RPT\_EAR\_0

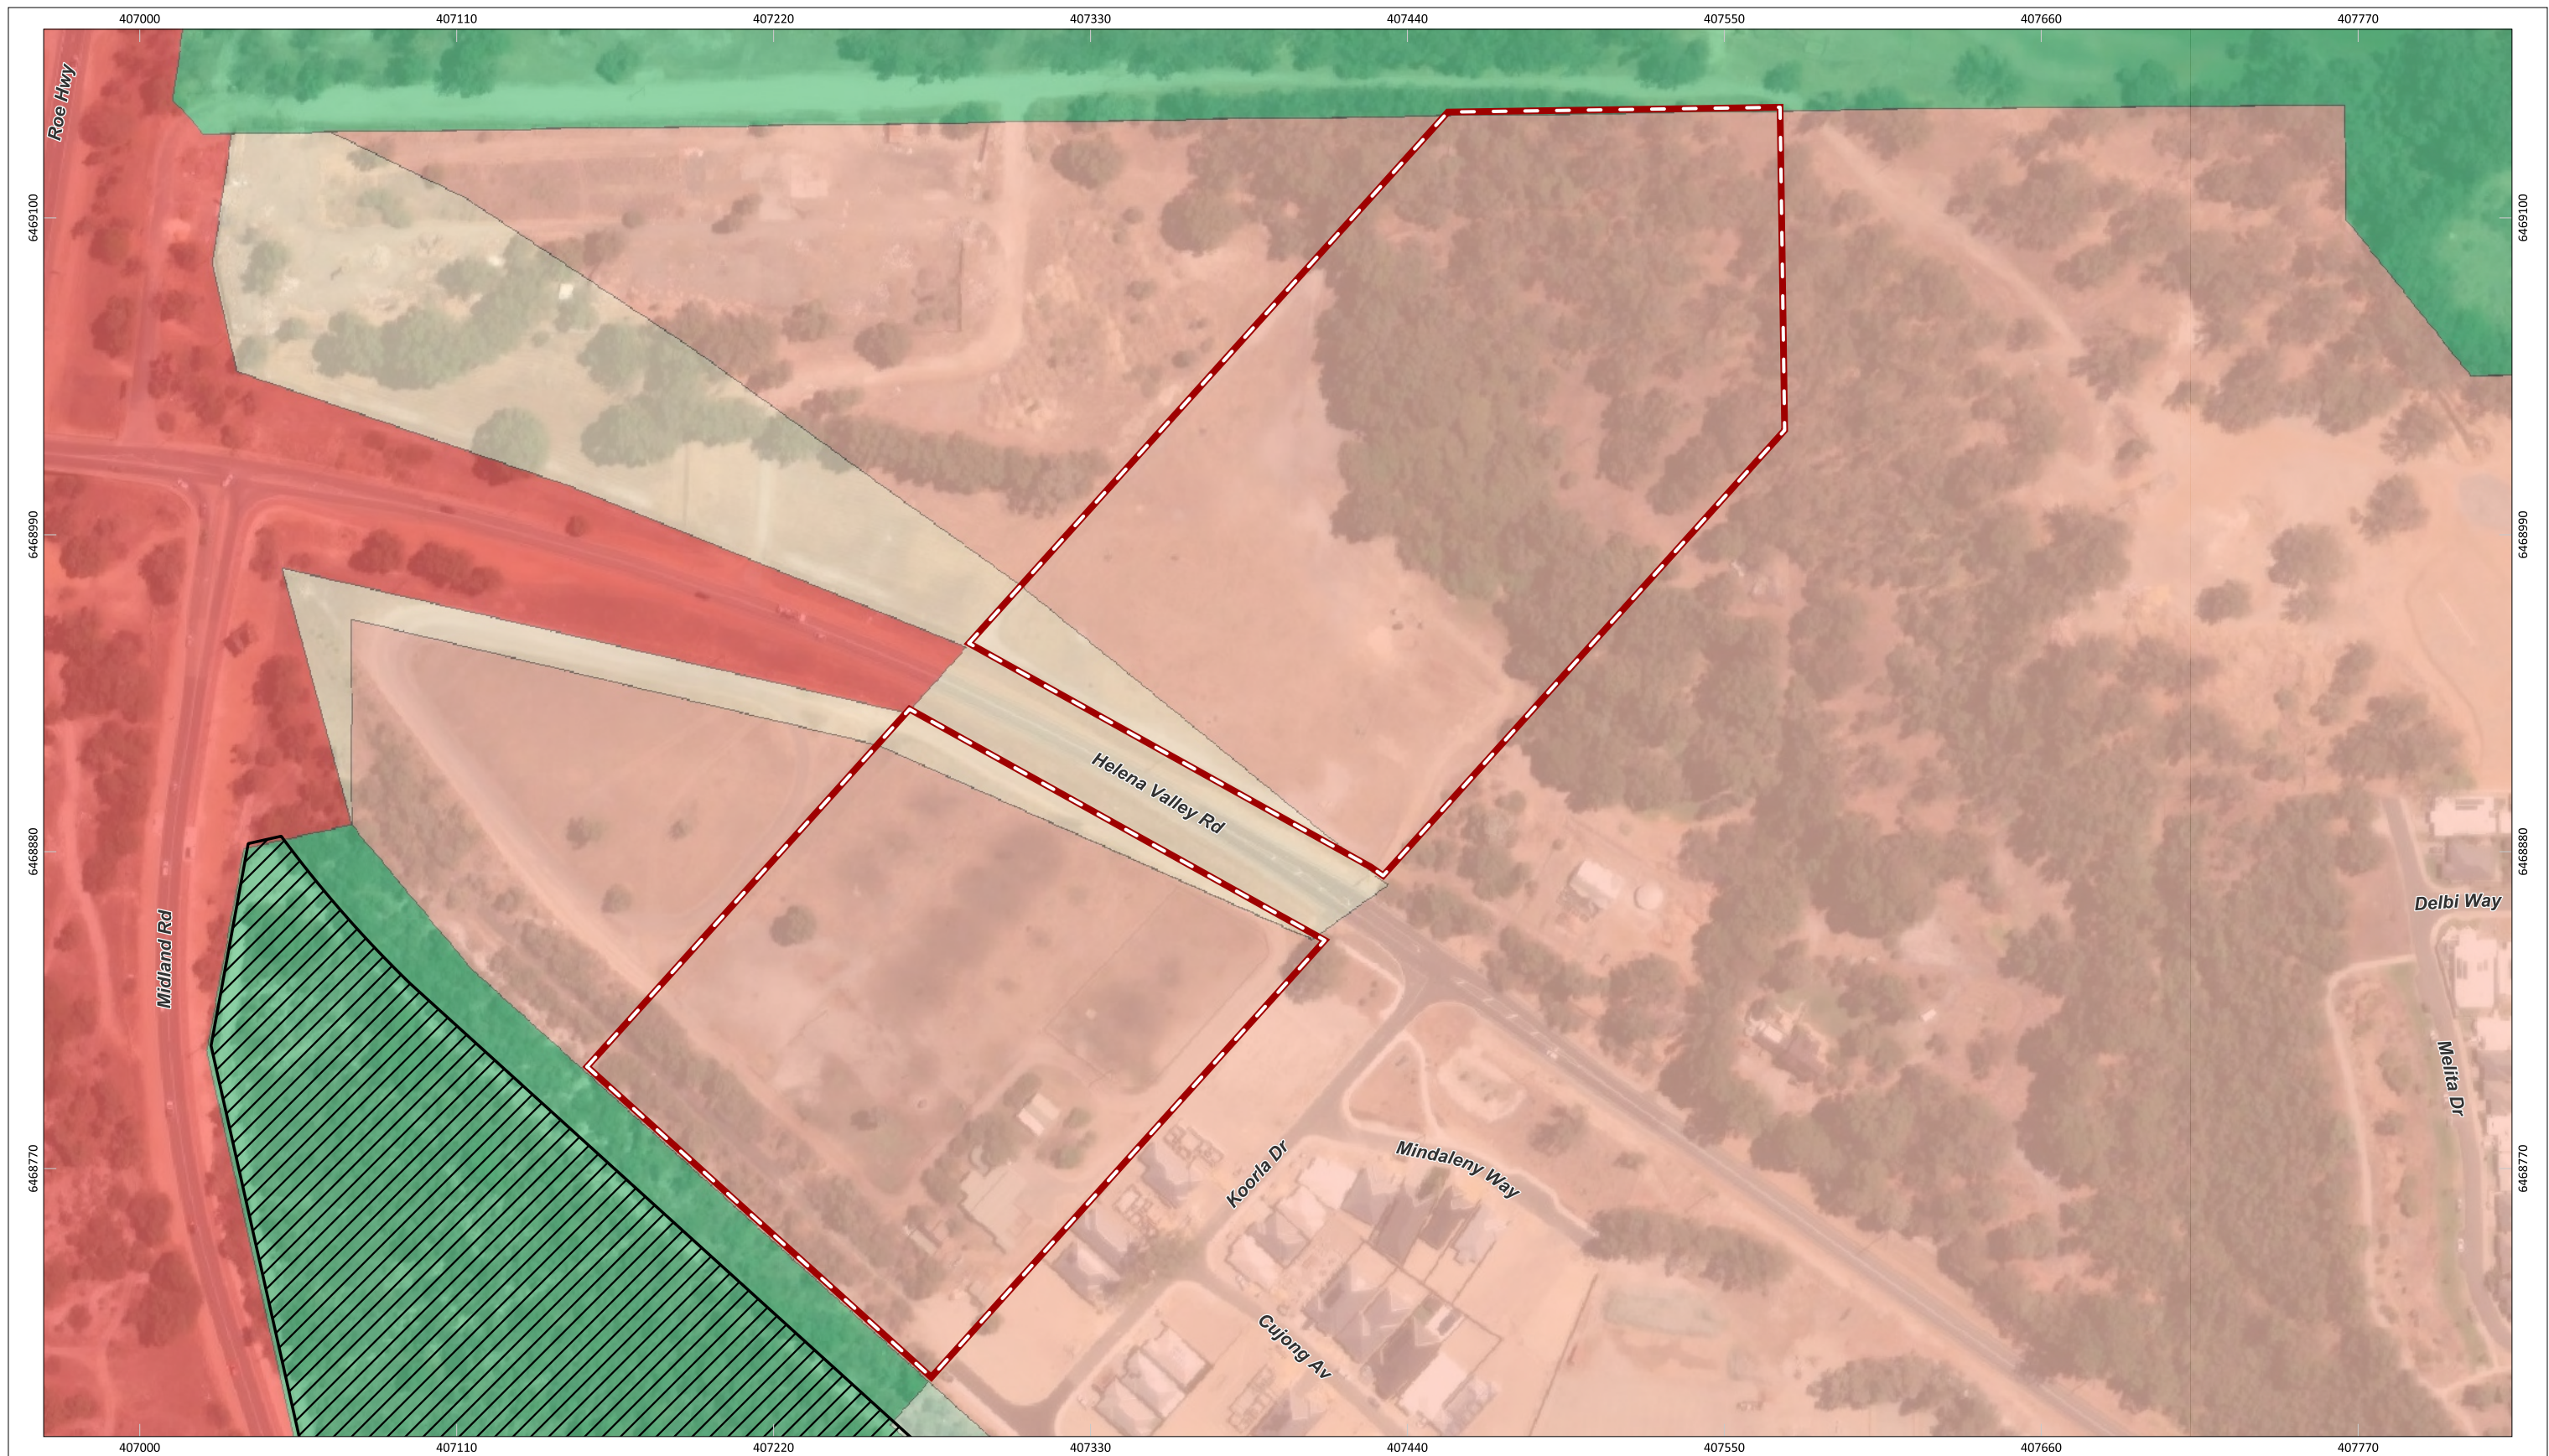
Figure 2: Metropolitan Region Scheme Zones and Reserves

The Site forms part of the Helena Valley Urban Precinct (HVUP) in the Shire of Mundaring, which was rezoned under the Metropolitan Region Scheme (MRS) as part of MRS Amendment 1425 from 'Rural' to 'Urban' and 'Urban Deferred'. Current MRS zones and reserves are provided on Figure 2. Concurrent rezoning occurred from 'Rural Residential' to 'Development', 'Important Local Roads' and 'Rural Residential' under the Shire of Mundaring Local Planning Scheme No. 4 (LPS 4).

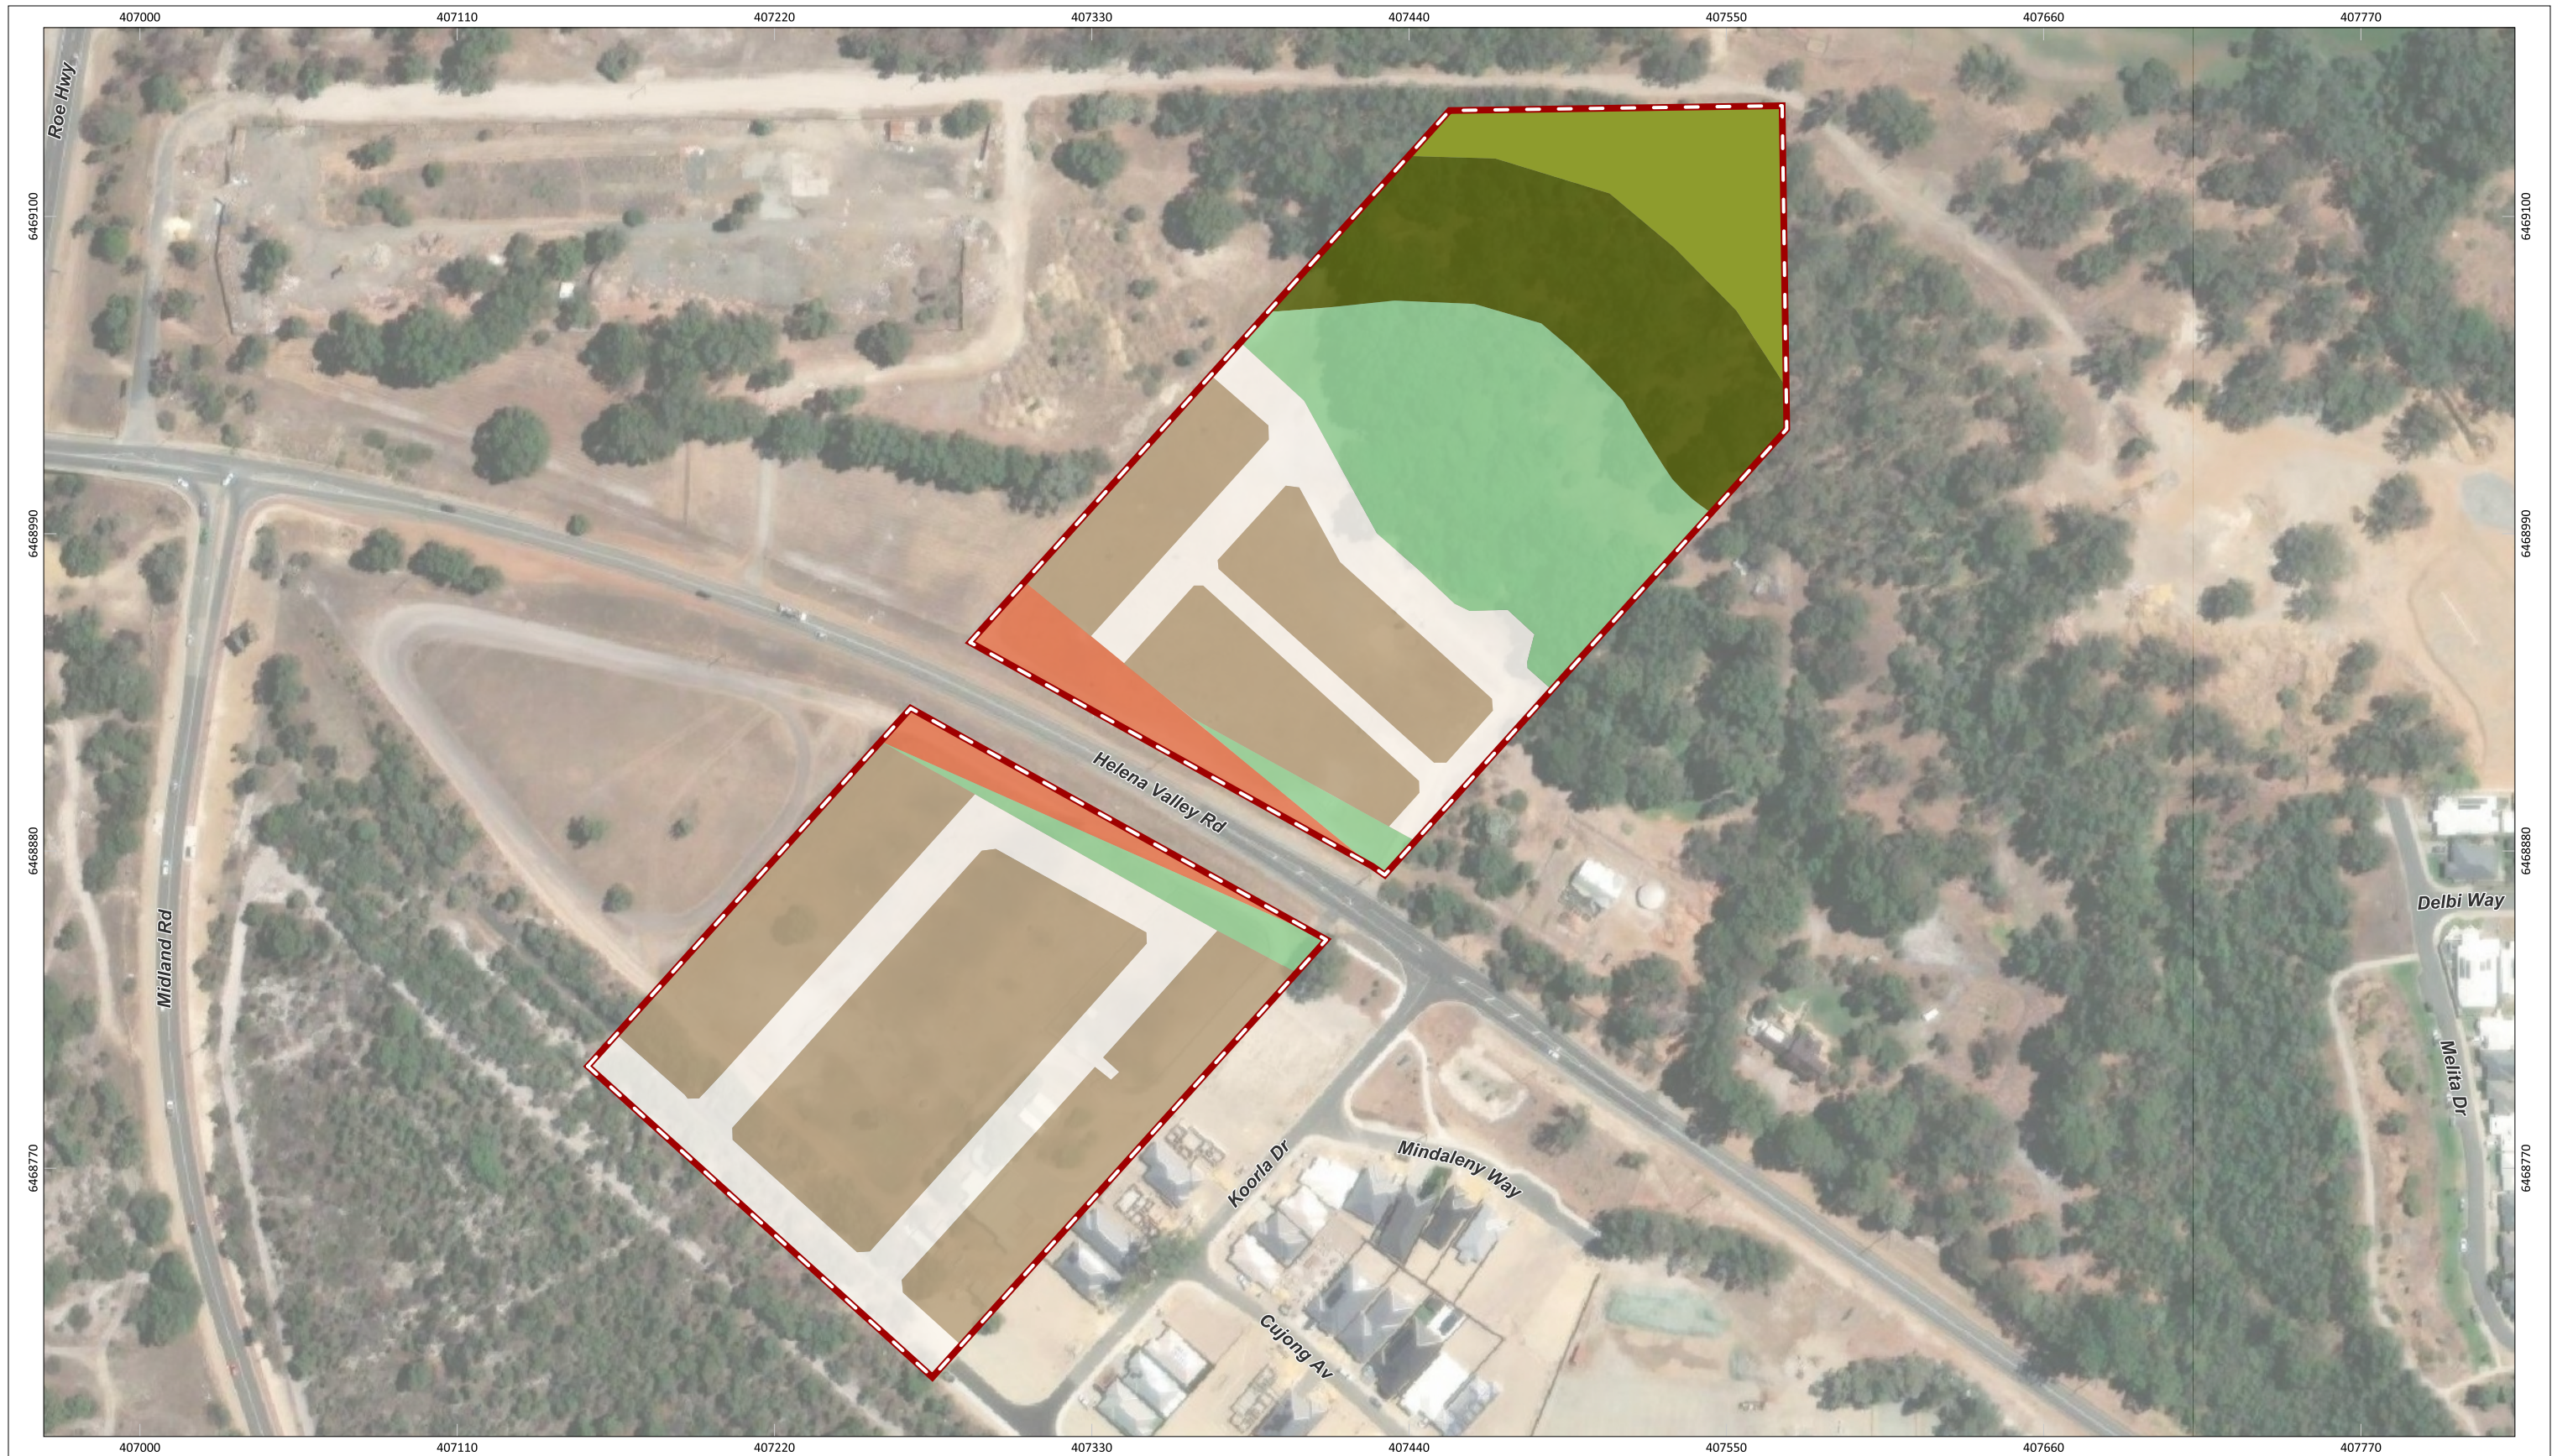
Figure 3: Concept Structure Plan

As shown in Figure 3, the Site is planned for residential development comprising of approximately 59 lots and three Public Open Space (POS) areas. A large portion of the Site (2.52 ha, 34.5%) is identified as POS1 which encompasses a Conservation Category Wetland (CCW) and associated wetland buffer, which form an interface with Kadina Brook which is adjacent to the north of the Site.

An EAR was previously completed by PGV Environmental (PGV; 2023) to facilitate the MRS Amendment application to rezone the Site to 'Urban'. This EAR has been completed with reference to the PGV EAR, however has been updated to support the Structure Plan. This EAR also has regard to comments received from key agencies on the MRS Amendment (Appendix A) and updates in the concept plan for the Site. The current concept structure plan is provided as Figure 3.

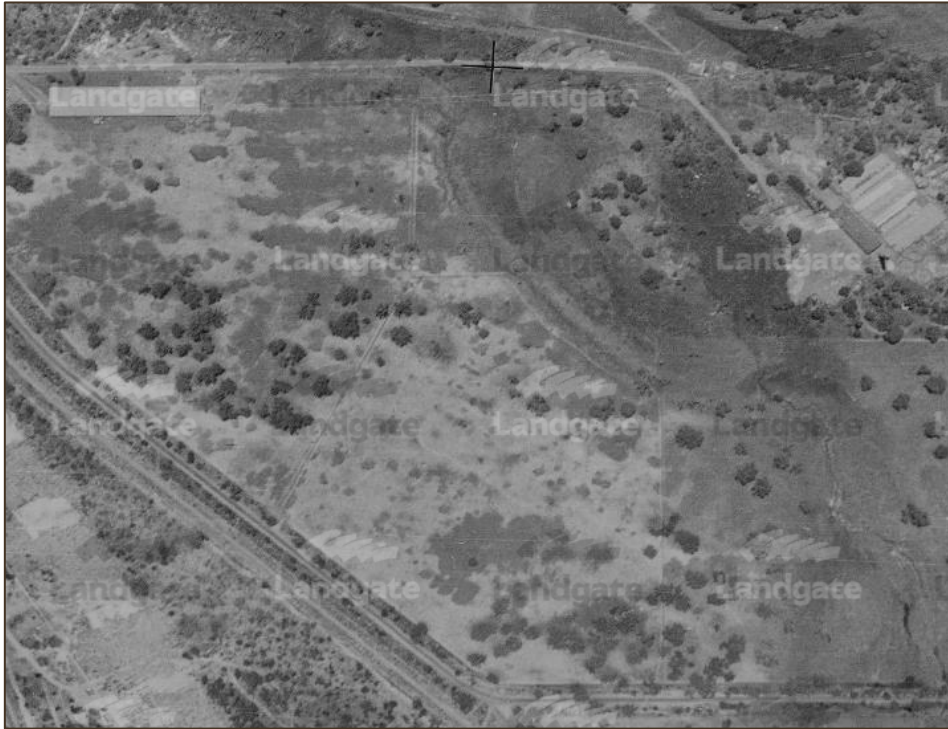
Historical aerial photographs (Landgate, n.d) of the Site and its surrounds were reviewed as part of this assessment as well as within the pre-existing surveys. The aerial imagery dated 30/10 to 27/11/1953 shows the Site was predominantly clear with sparse native vegetation throughout (Plate 1). Minor development of intersecting roads can be seen through both lots.

**Plate 1: Aerial imagery of the Site in 1953 (Landgate, 2025).**

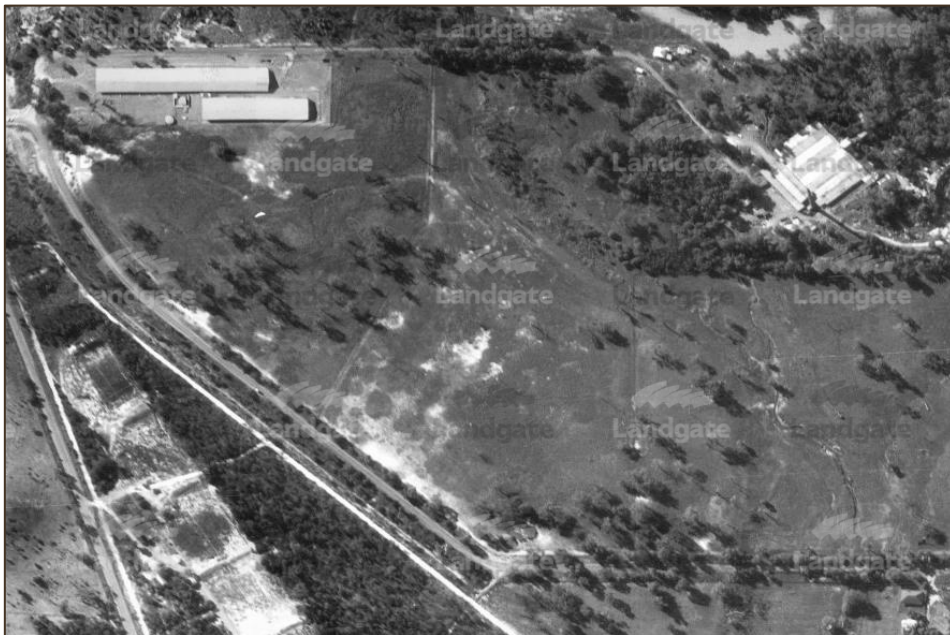
Over the following two decades there was limited further development, and native vegetation increased in density, particularly in the northern most area of the Site associated with Kadina Brook (Plate 2). By 1995 the Site has predominantly been cleared, particularly in the south. The north is cleared with exception for the vegetation associated Kadina brook and isolated trees which appear to be dead, or lacking canopy (Plate 3).

**Plate 2: Aerial imagery of the Site dated 10/07-06/09/1974 (Landgate, 2025).**

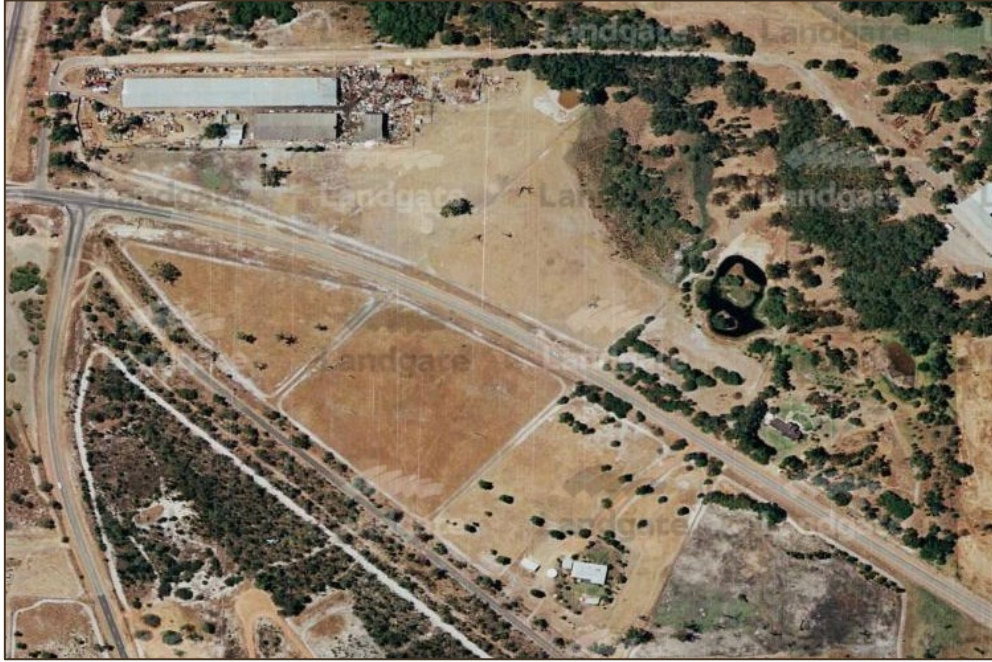
**Plate 3: Aerial imagery of the Site dated 11/01-06/02/1995 (Landgate, 2025).**

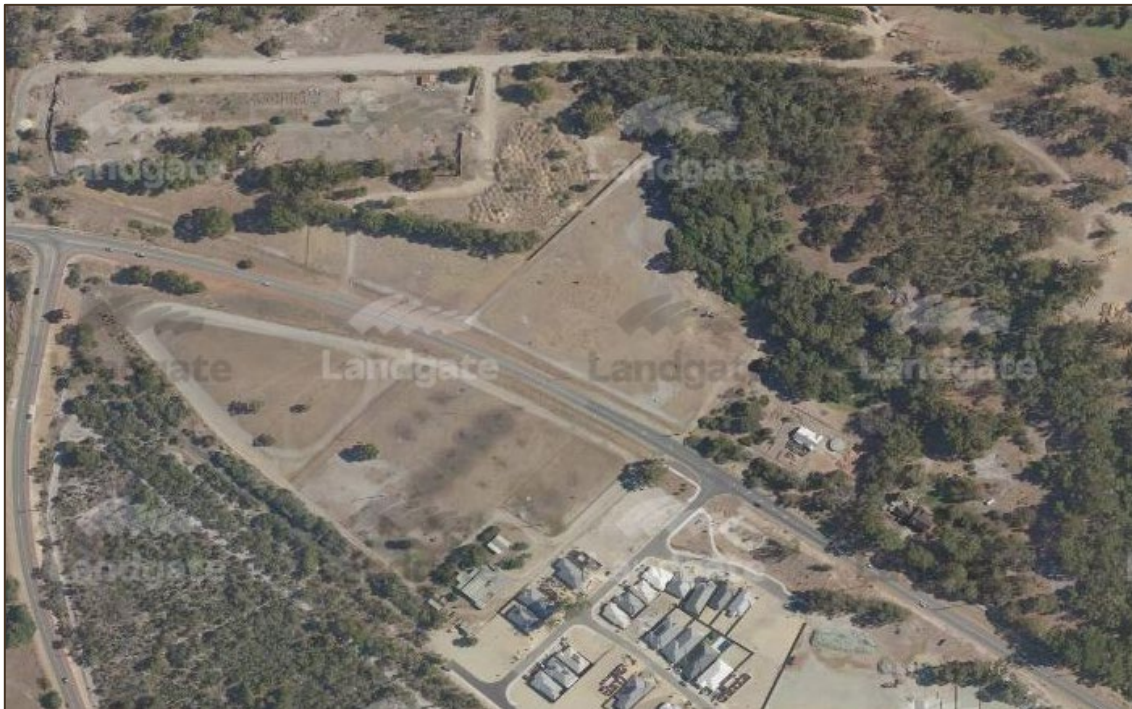
The imagery dated 2007 to 2008 shows the development of a permanent dwelling structure in the south and vehicular tracks in the north. The most recent imagery shows the south of the Site has remained mostly cleared with the dwelling remaining, and two isolated trees (Plate 4). The north is also cleared, with a distinct delineation of the creek vegetation which has substantially increased in density.

**Plate 4: Aerial imagery dated 05-16/02/2025 (Landgate, 2025).**

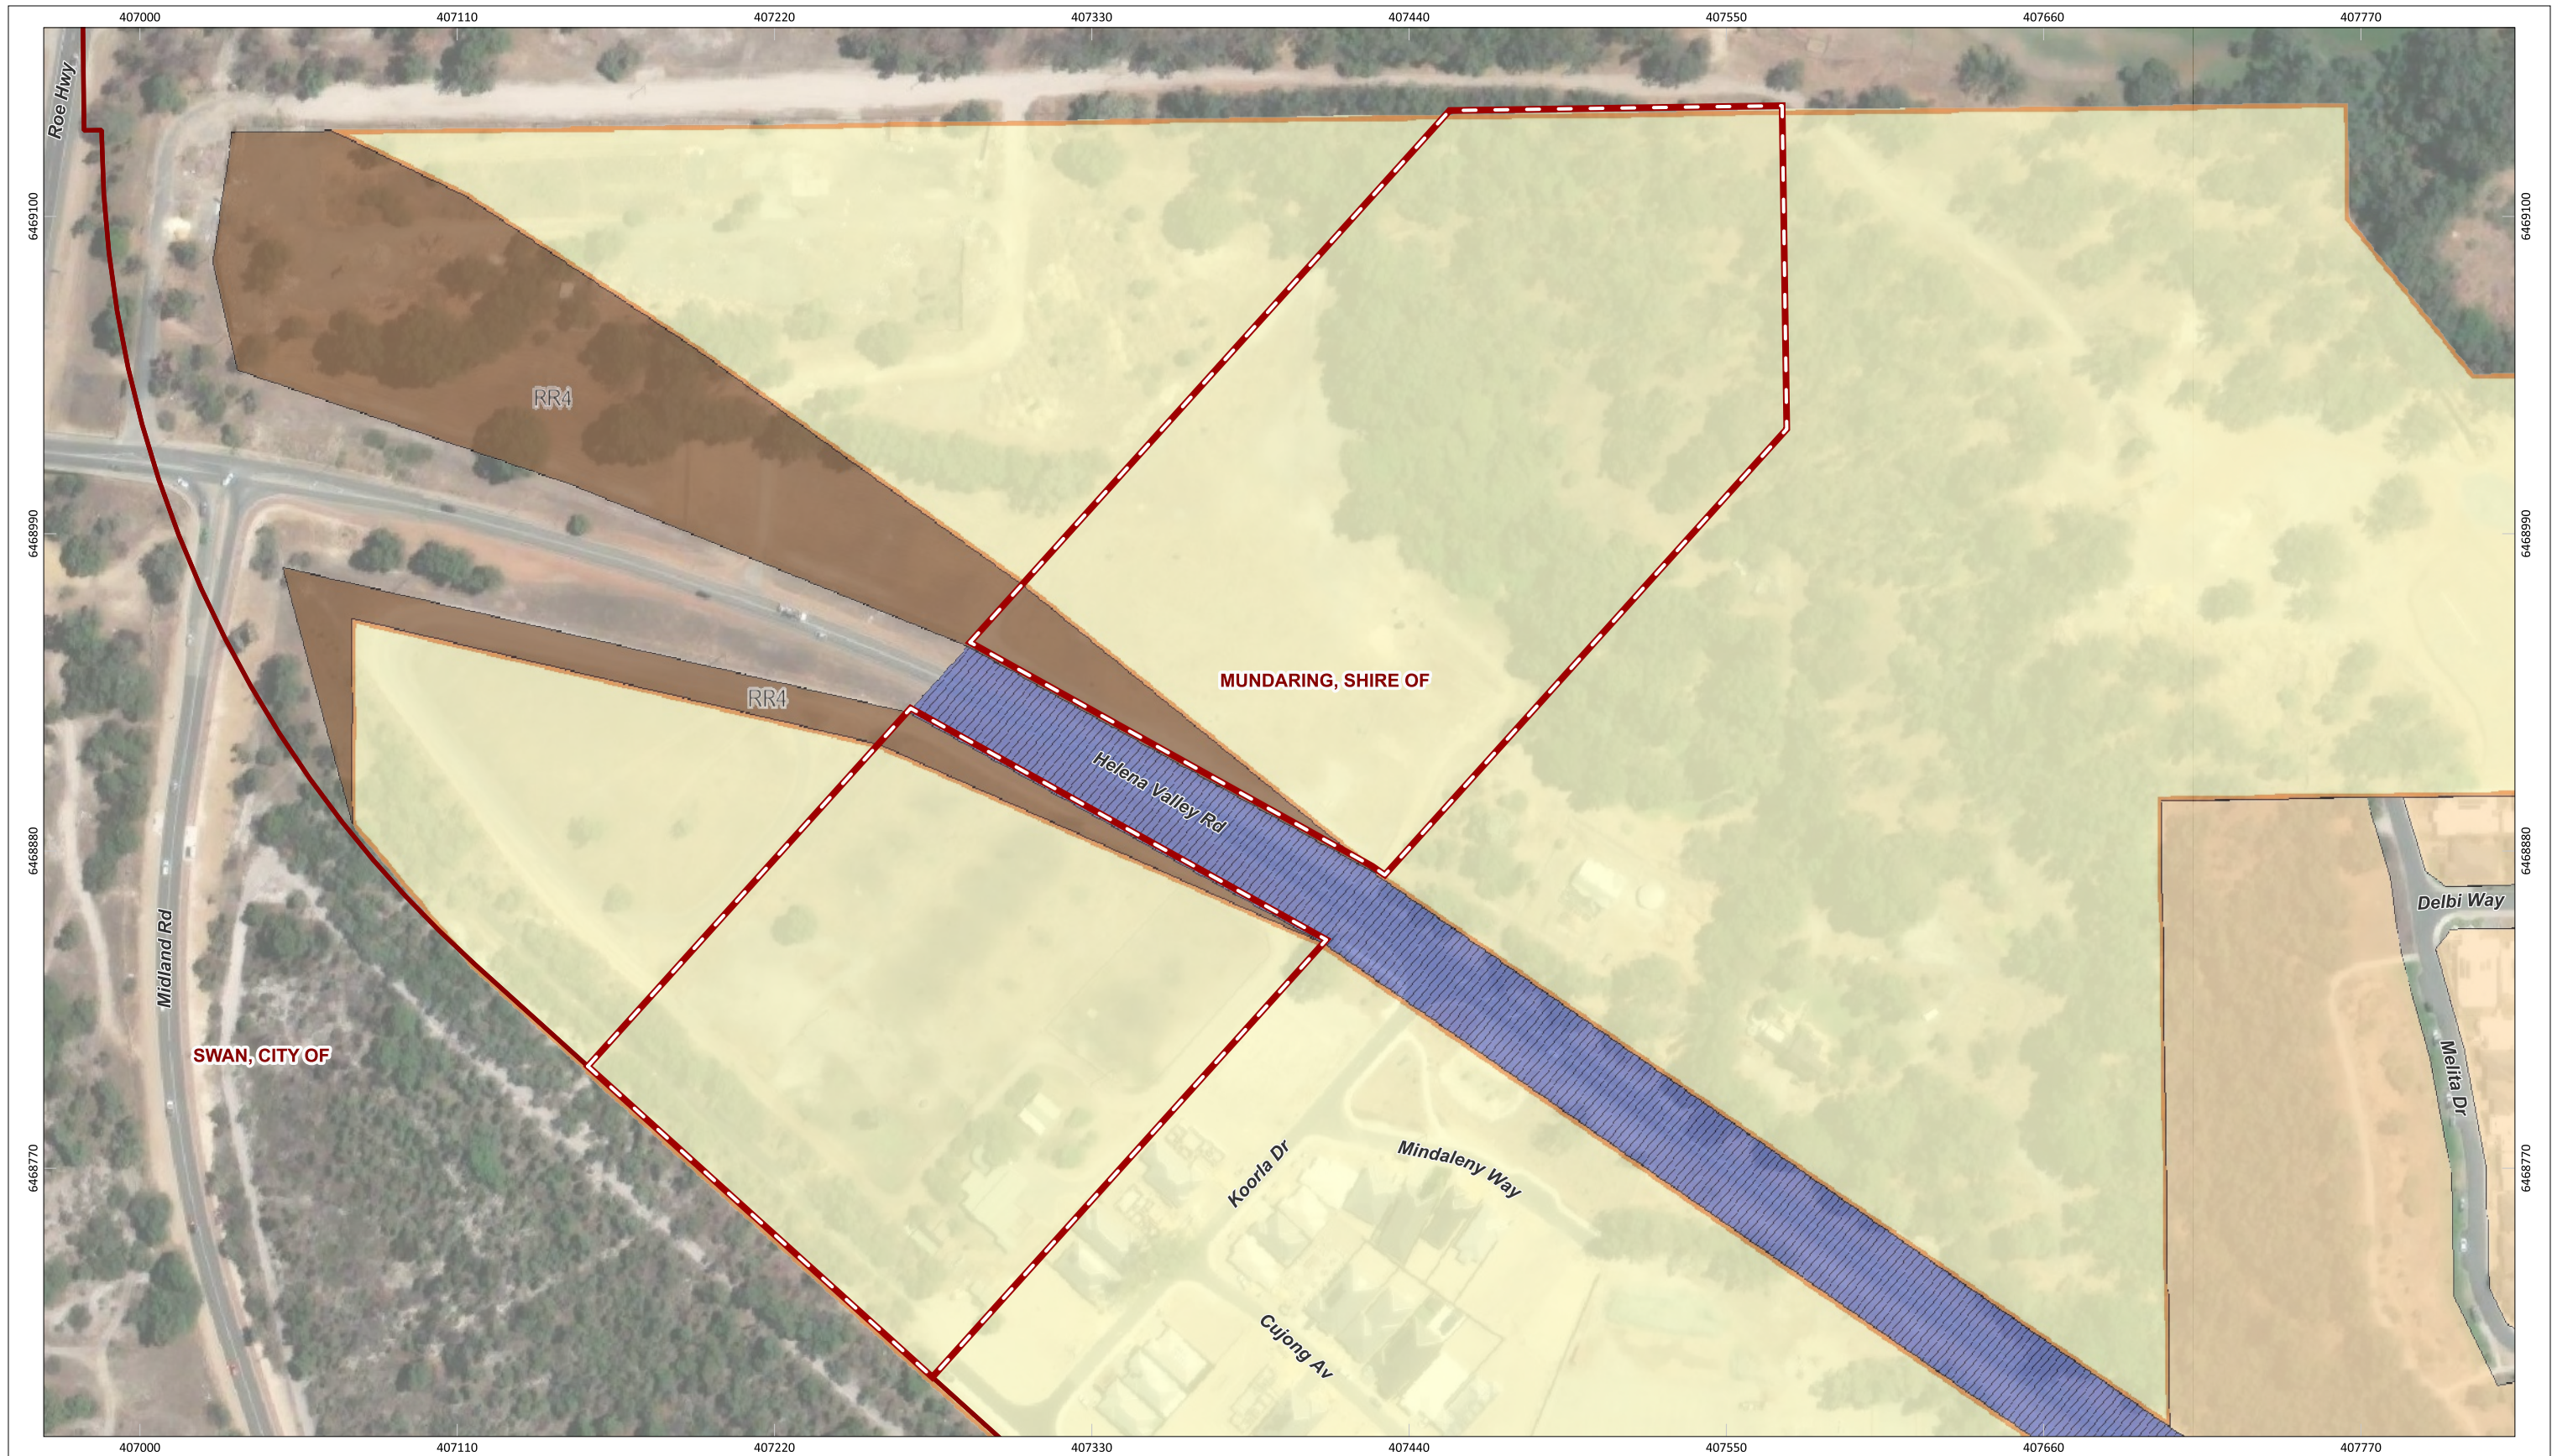
Figure 4: Surrounding Land Use and Zoning

A review of current aerial imagery identified the following current land uses surrounding the Site (Figure 4 and Figure 4):

- North - The land is zoned as 'Regional Open Space' (ROS) under the MRS and is not zoned under LPS 4. This area is associated with Kadina Brook.
- East - Remnant native vegetation and a rural residential lot both zoned as 'Rural' and 'Urban' under the MRS, the former also zoned as ROS. Under the LPS 4 the zoning is 'Rural Residential' and 'Development'.
- South - Remnant native vegetation is present, which is included within Bush Forever Site 213.
- West - Predominantly cleared land, zoned as 'Rural' under the MRS and 'Rural Residential' under LMS No 4 and City of Swan Scheme No. 17, with sparse vegetation which is intersected by Midland Road and Roe Highway.

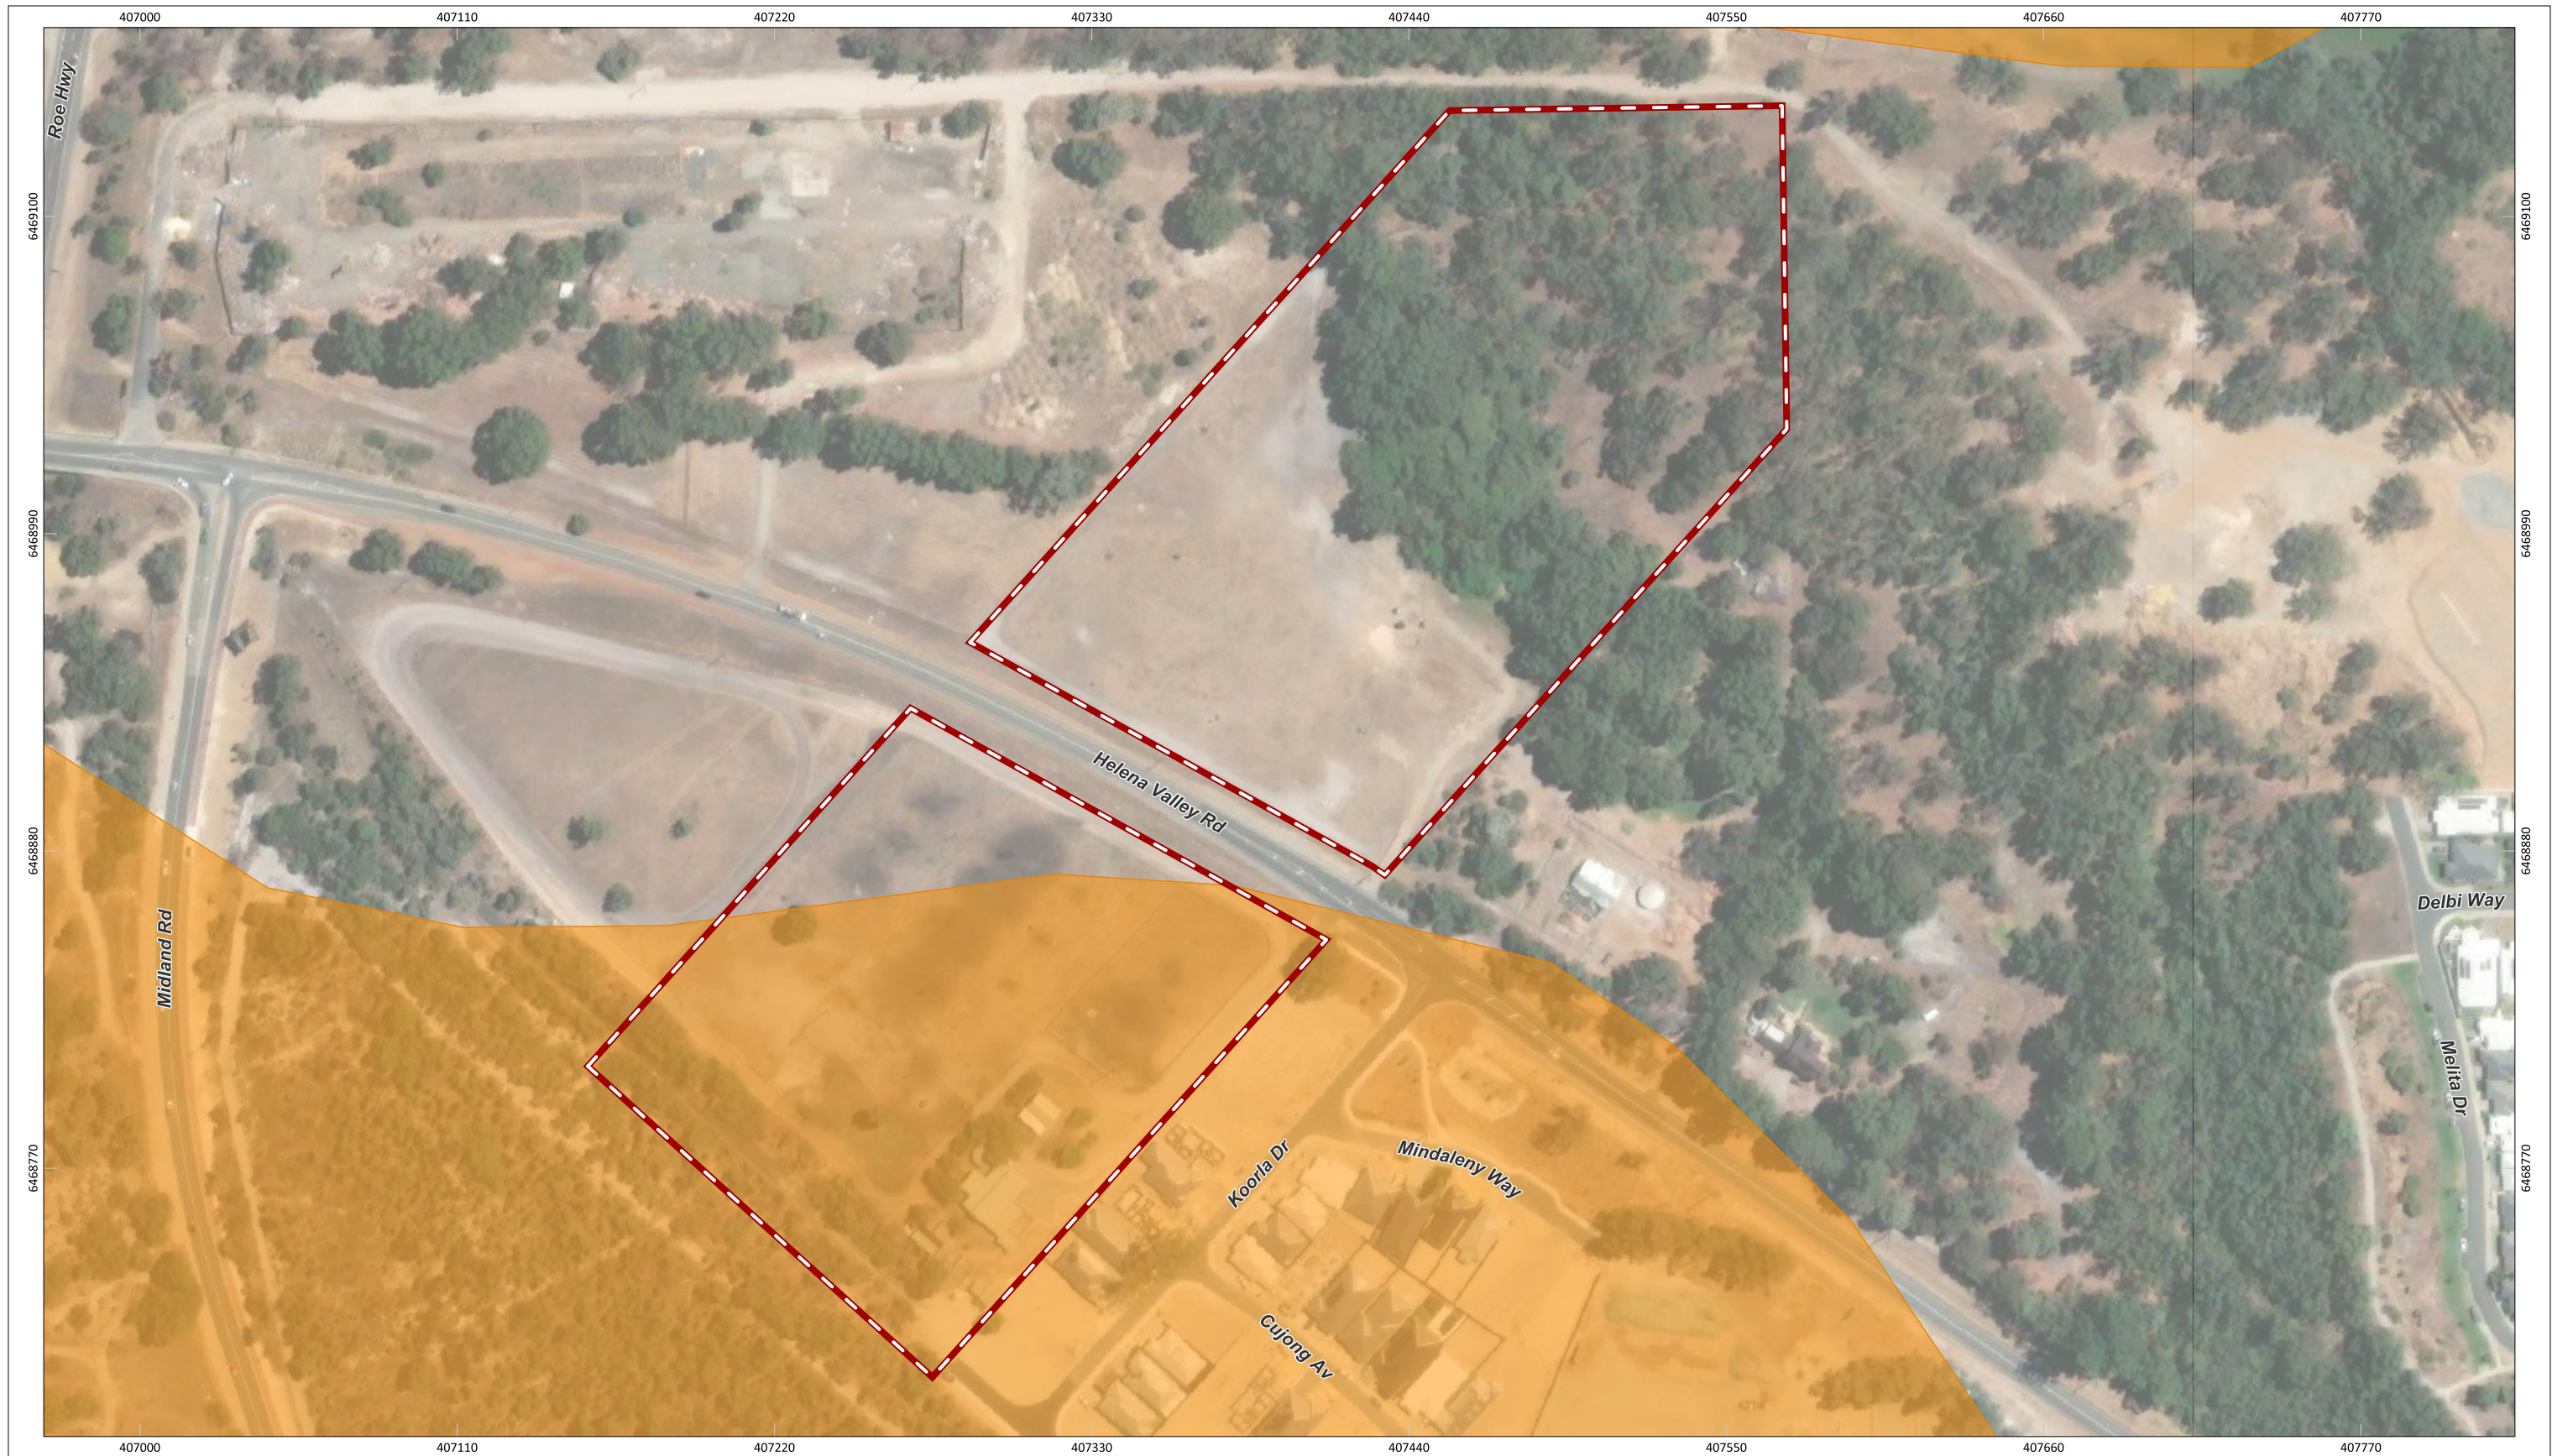
Figure 6: Acid Sulfate Soils Risk

A large proportion of the Site, including the whole of the northern lot, does not have Acid Sulfate Soil (ASS) risks mapped (DWER-055). The southern portion of the Site (2.24 ha; 30.7% of Site) is mapped as having a moderate to low risk of ASS occurring within 3 m of the natural soil surface and a high risk of it occurring beyond 3 m (Figure 6).

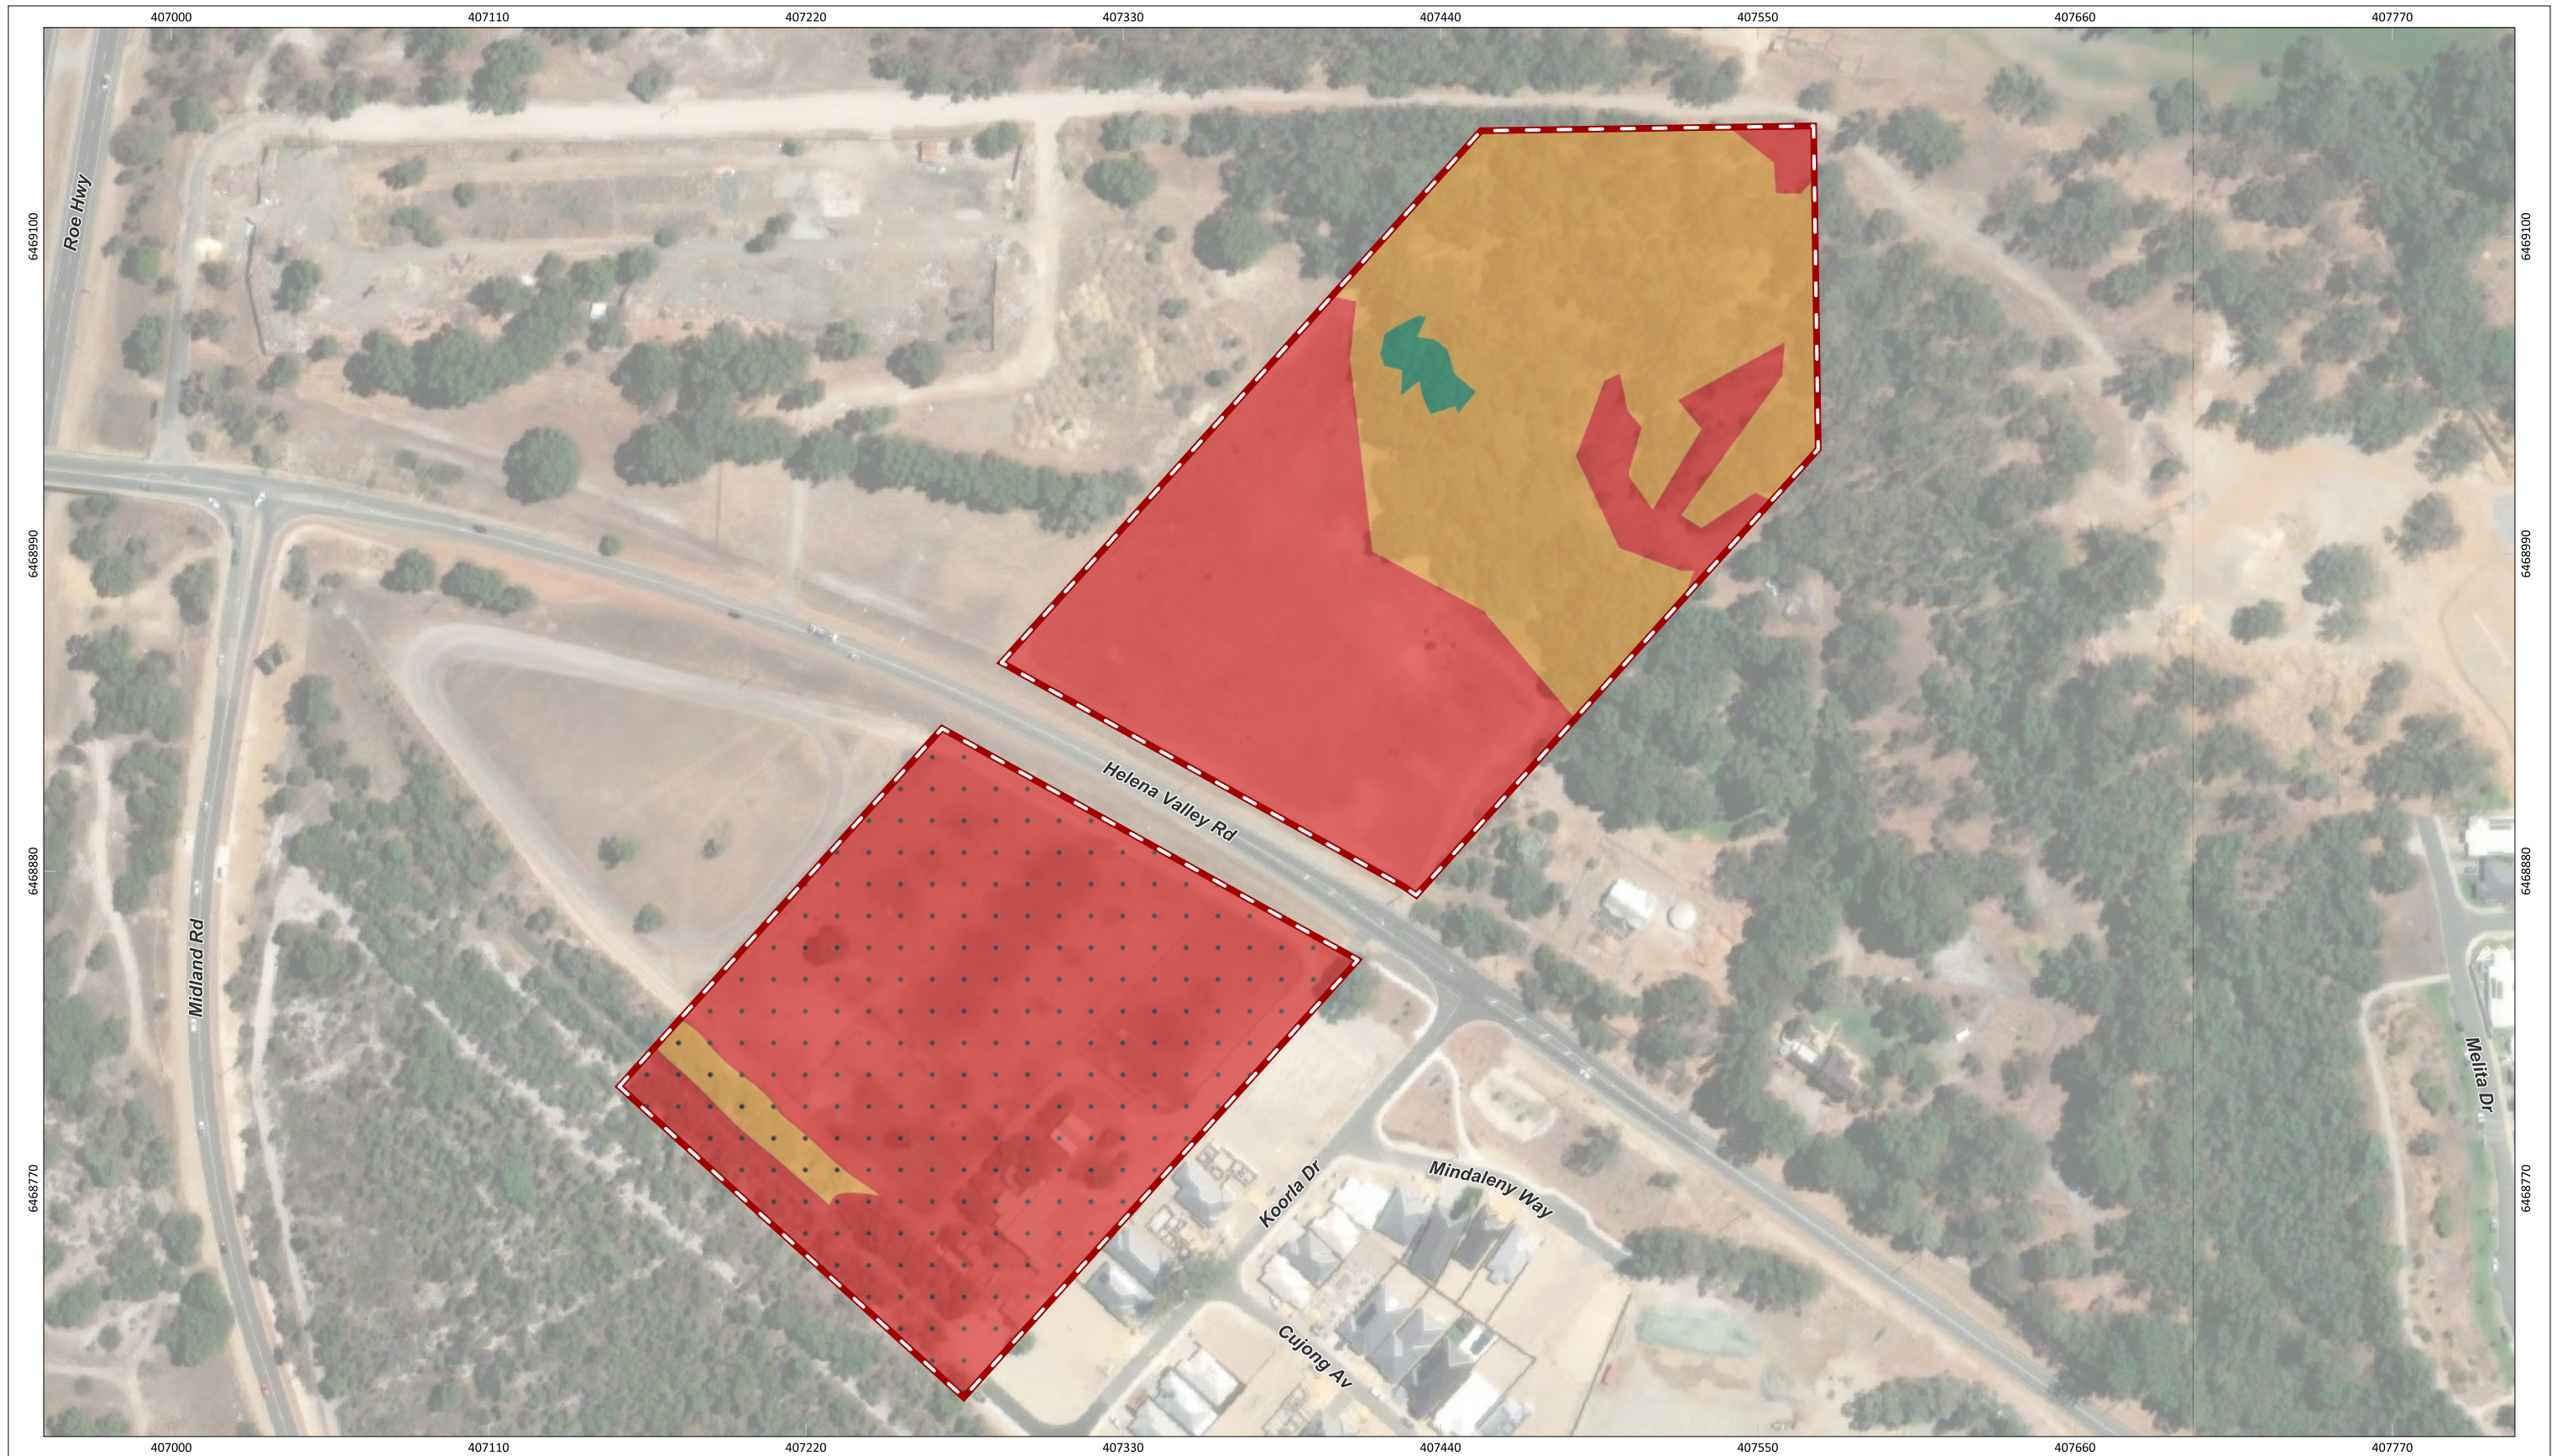
Figure 12: Vegetation Conditions

The majority of the vegetation on Site was identified by PGV (2022) as Degraded to Completely Degraded condition, per the Keighery Scale (EPA, 2016a) further described in Table 3-7 and presented in Figure 12. A single patch of vegetation type 'Er' was assessed to be in Very Good condition. The overall condition was described to be of low quality, and this was due to the high proportion of regrowth vegetation with a dense population of Victorian Tea tree (*L.laevigatum*) and other weeds within the foreshore area (PGV, 2022).
