# Helena Valley Urban Precinct

## Environmental Assessment Report

A25.232\_RPT\_EAR\_0

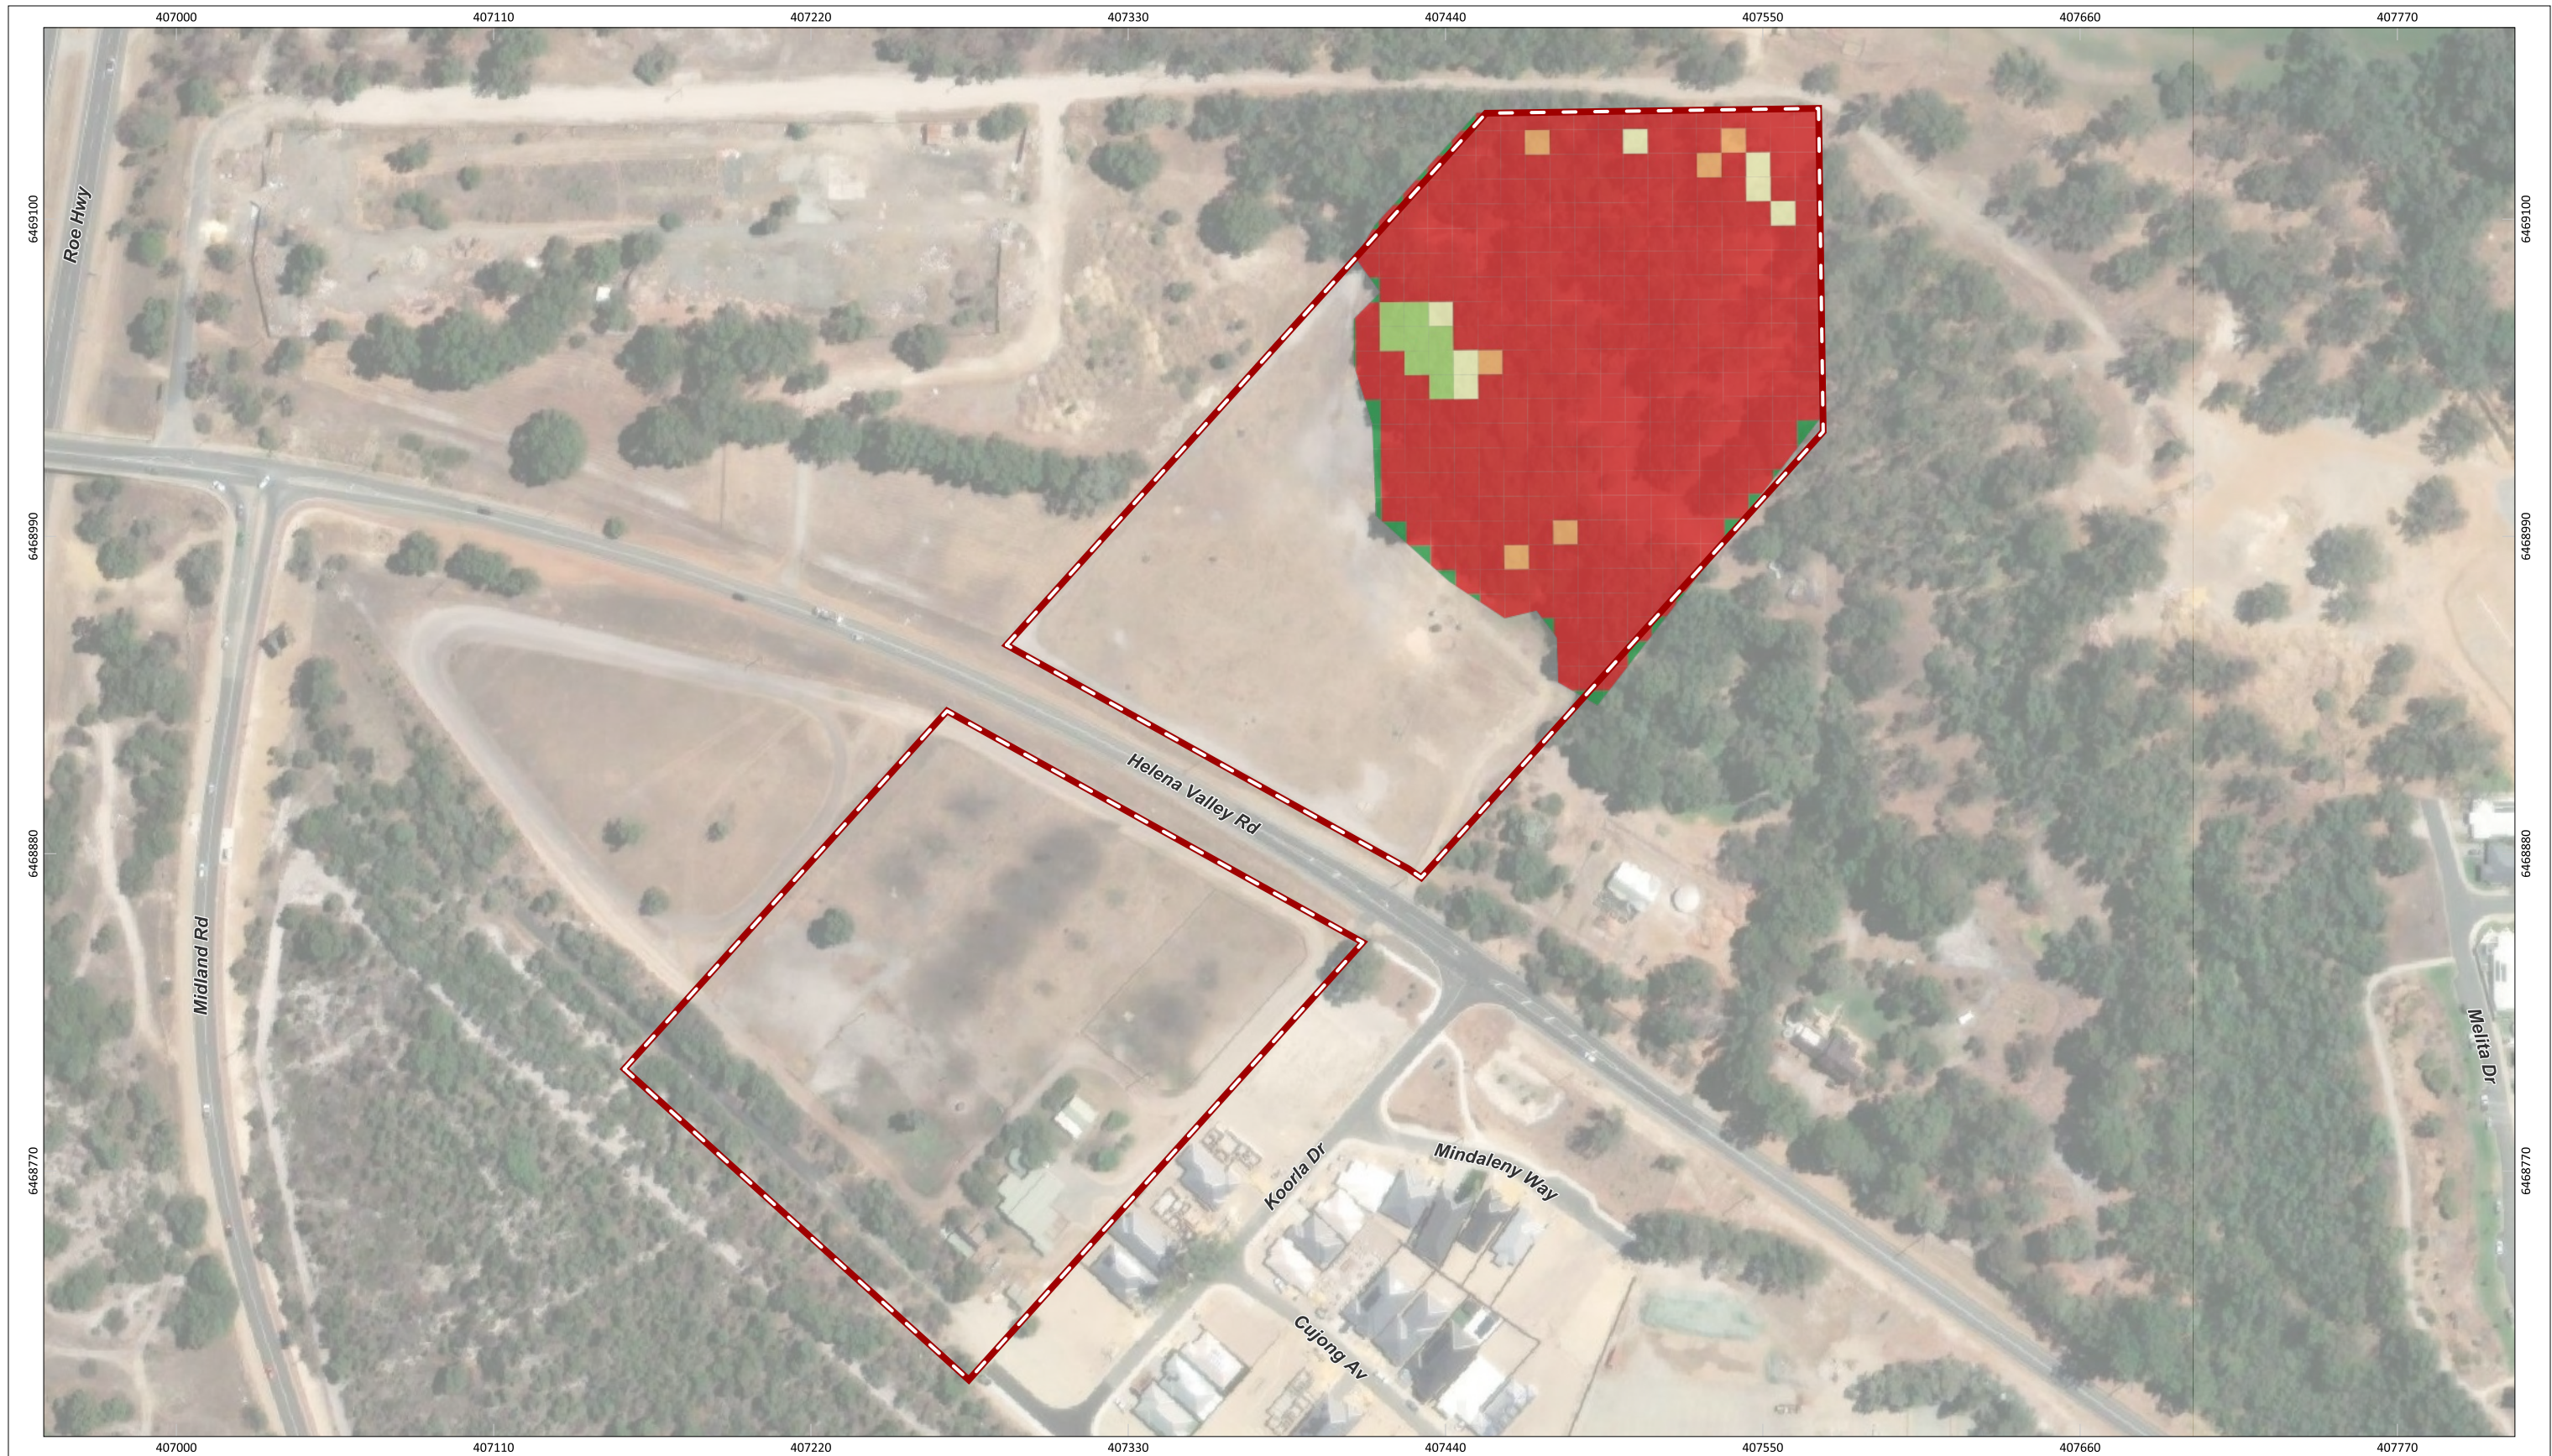
Figure 13: Weed Load within the Foreshore Area (Gambara, 2025)

Gambara (2025) identified that the majority of the Site is infested with high level weed load (more than 50% cover), due to ground cover grasses and overstorey of *\*Schinus terebinthifolius* (Brazilian Peppertree) infestations. Mapped weed load is shown in Figure 13.

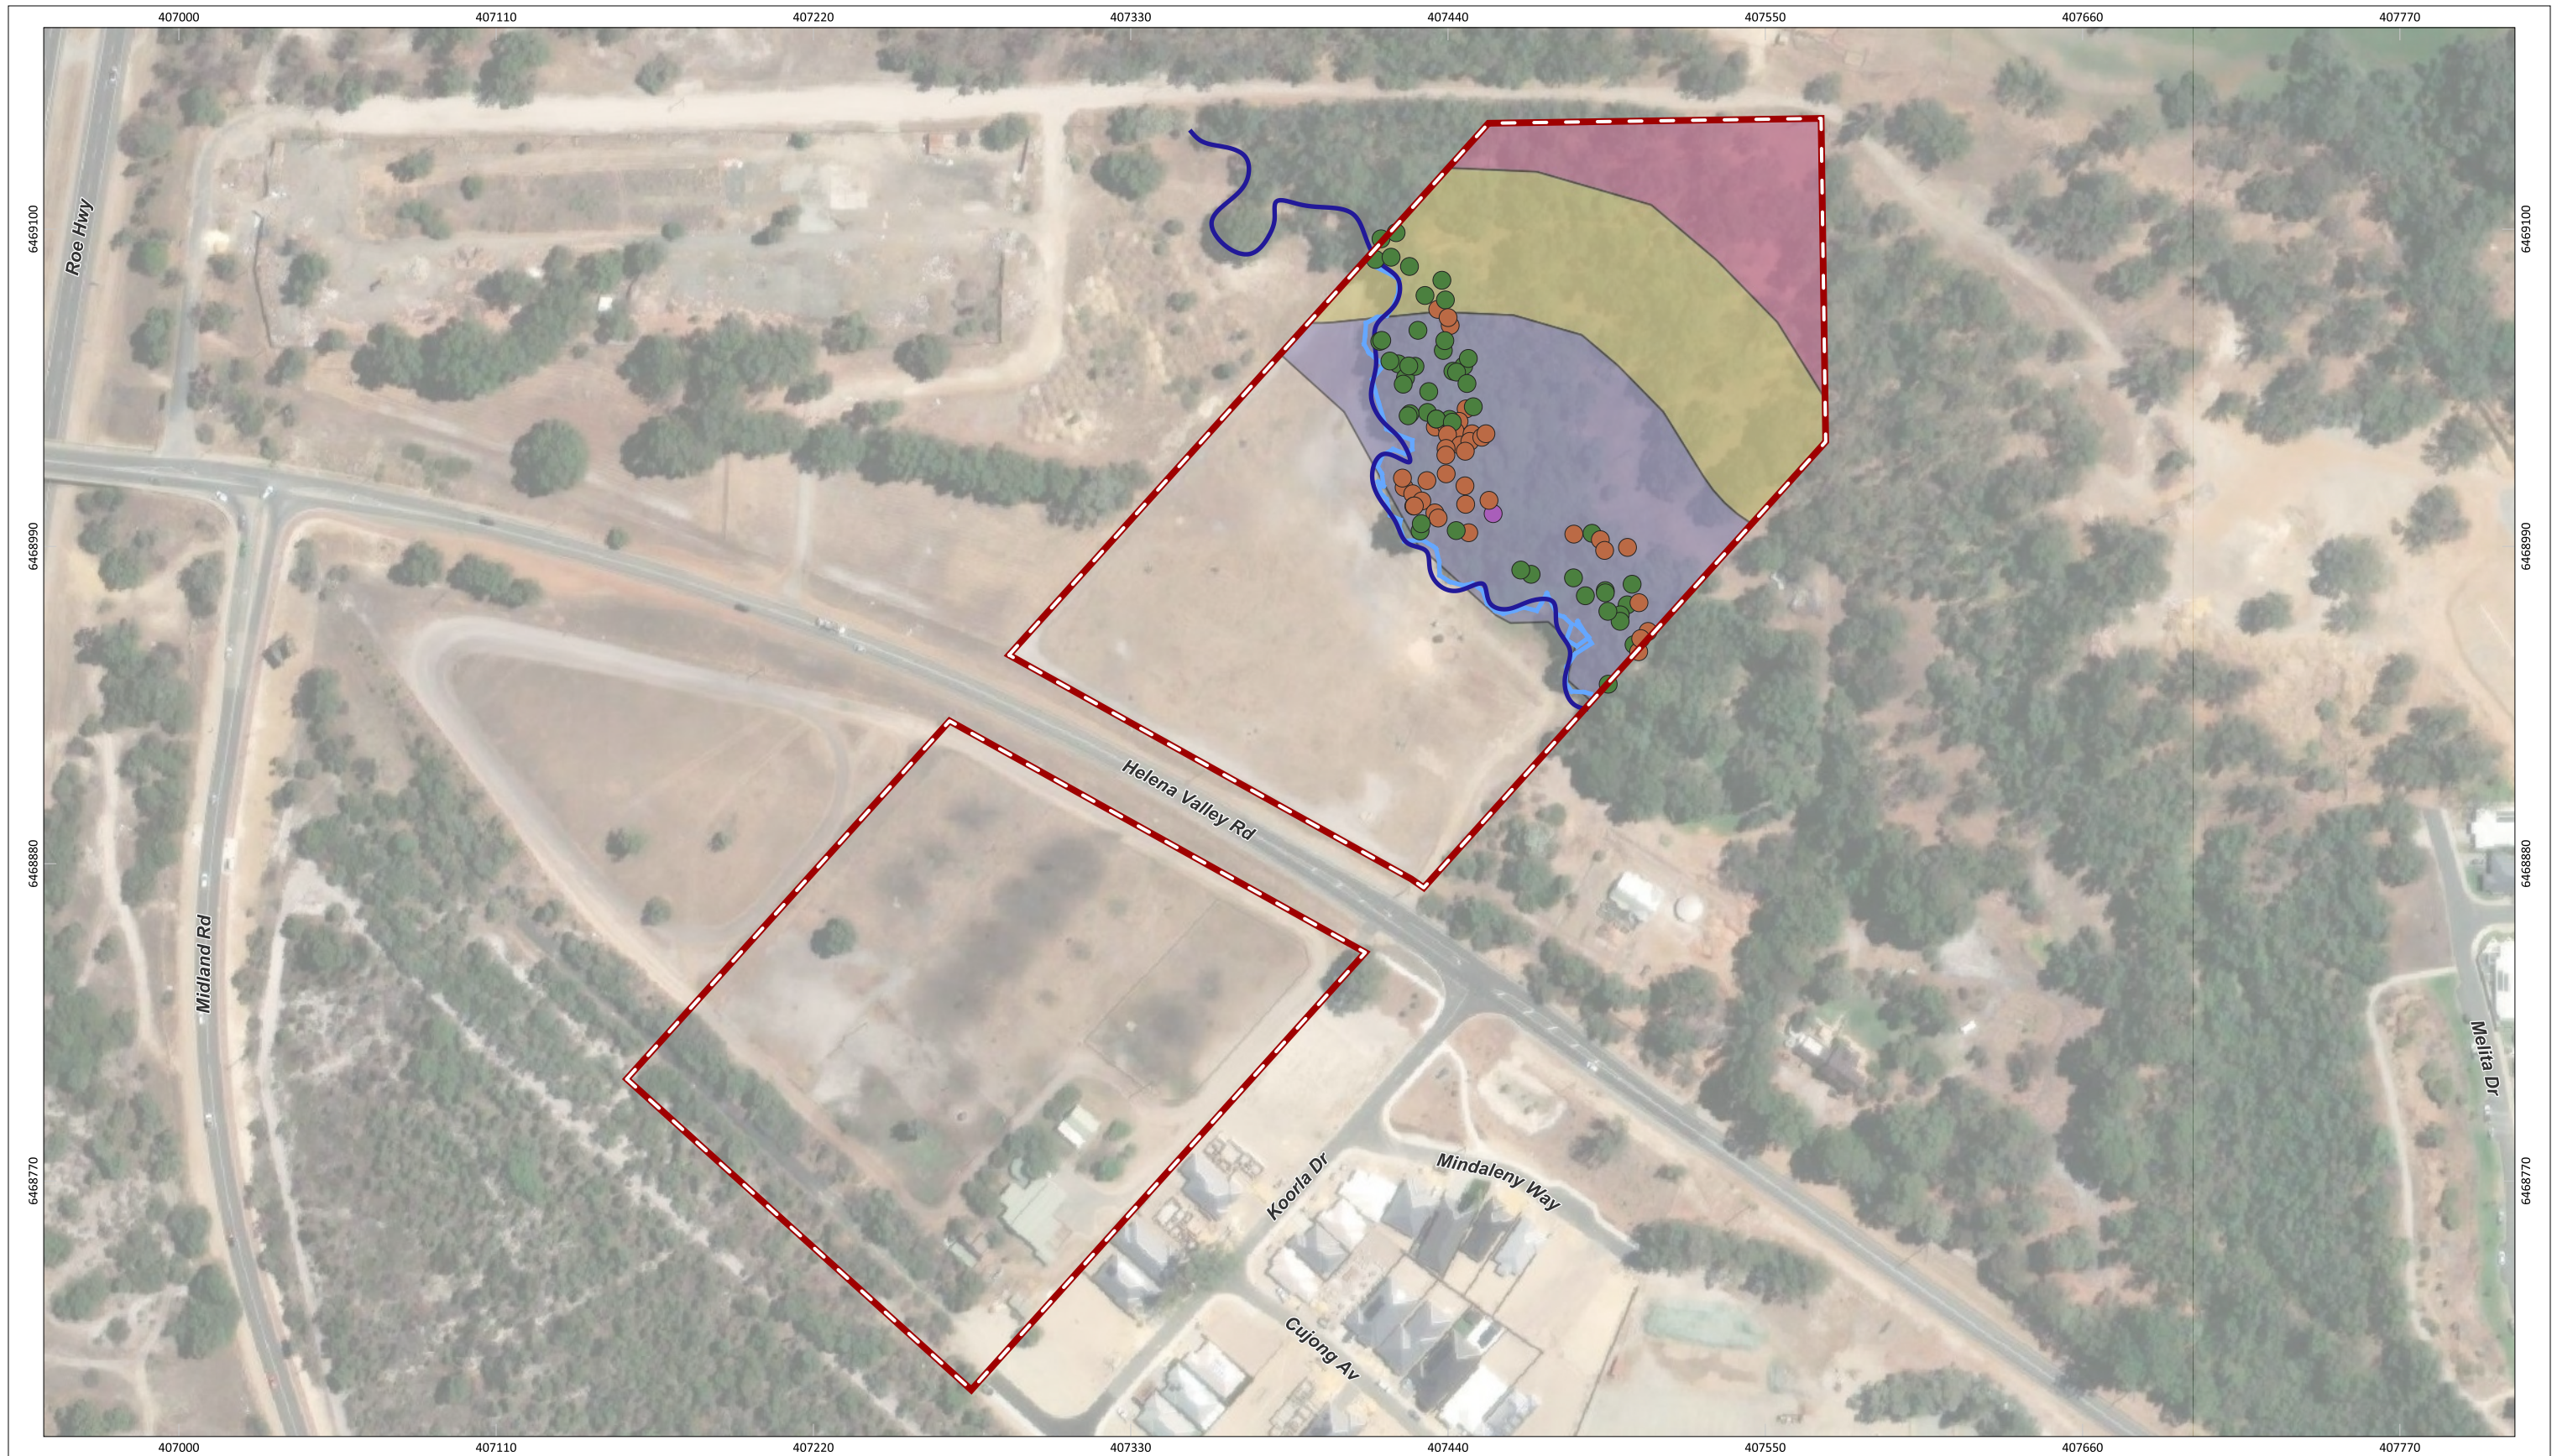
Figure 14: Previous and Proposed Foreshore Area

Updated vegetation extent mapping was undertaken by Gambara (2025), as part of their site assessment. This information is shown in Figure 14. A total extent of 2.51 ha of native vegetation was mapped by Gambara. The vegetation extent remains the same, however the condition values vary. Gambara found an increased distribution of Degraded vegetation by 0.4 ha, with a reduced distribution of Completely Degraded vegetation by 0.3 ha, and of Very Good vegetation by 0.1 ha (Appendix D).

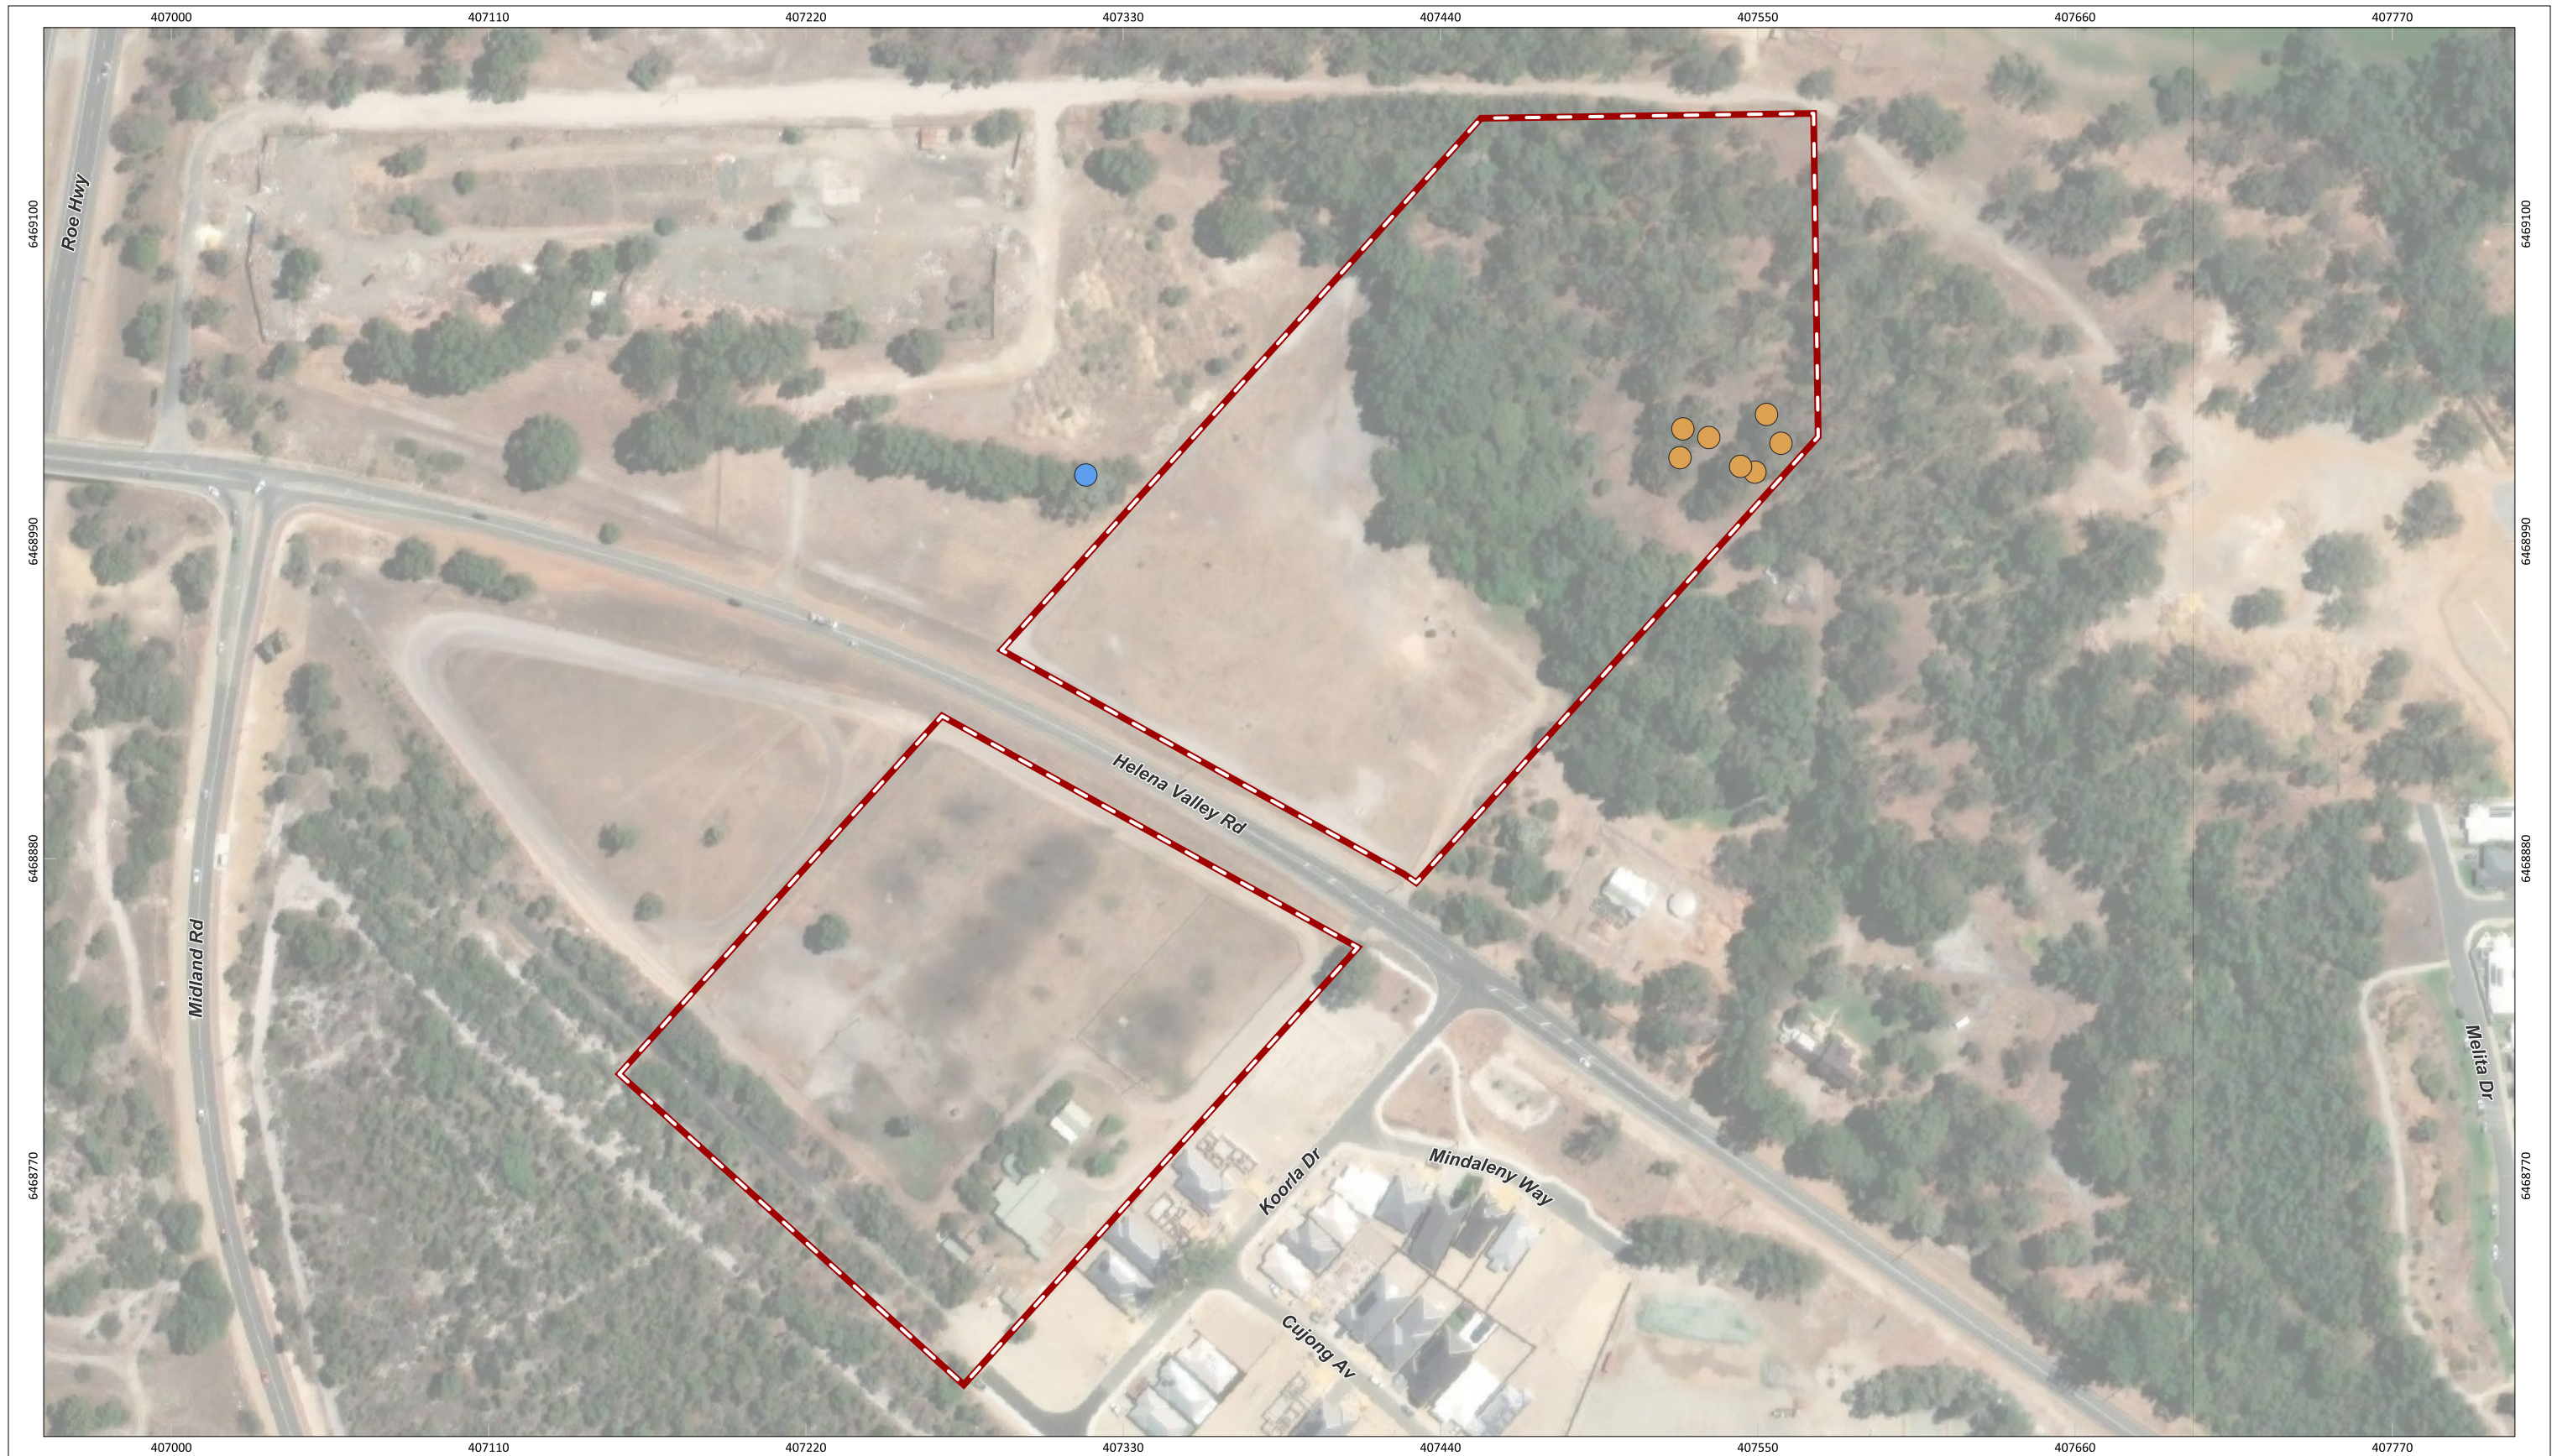
Figure 15: Potential Black Cockatoo Nesting Trees

Two vegetation types within the Site included eucalypt trees, 'Ew' *Eucalyptus wandoo* (wandoo), and 'Er' *Eucalyptus rudis* (flooded gum). Seven potential nesting trees were recorded by PGV (2022) within the Site (Figure 15). All seven are identified as wandoo with a measured DBH over the minimum requirement of 300 mm for the species, as documented in the *Referral guideline for 3 WA threatened black cockatoo species* (DAWE, 2022). There were no flooded gums recorded to be potential nesting trees, and no hollows were observed (PGV, 2022).

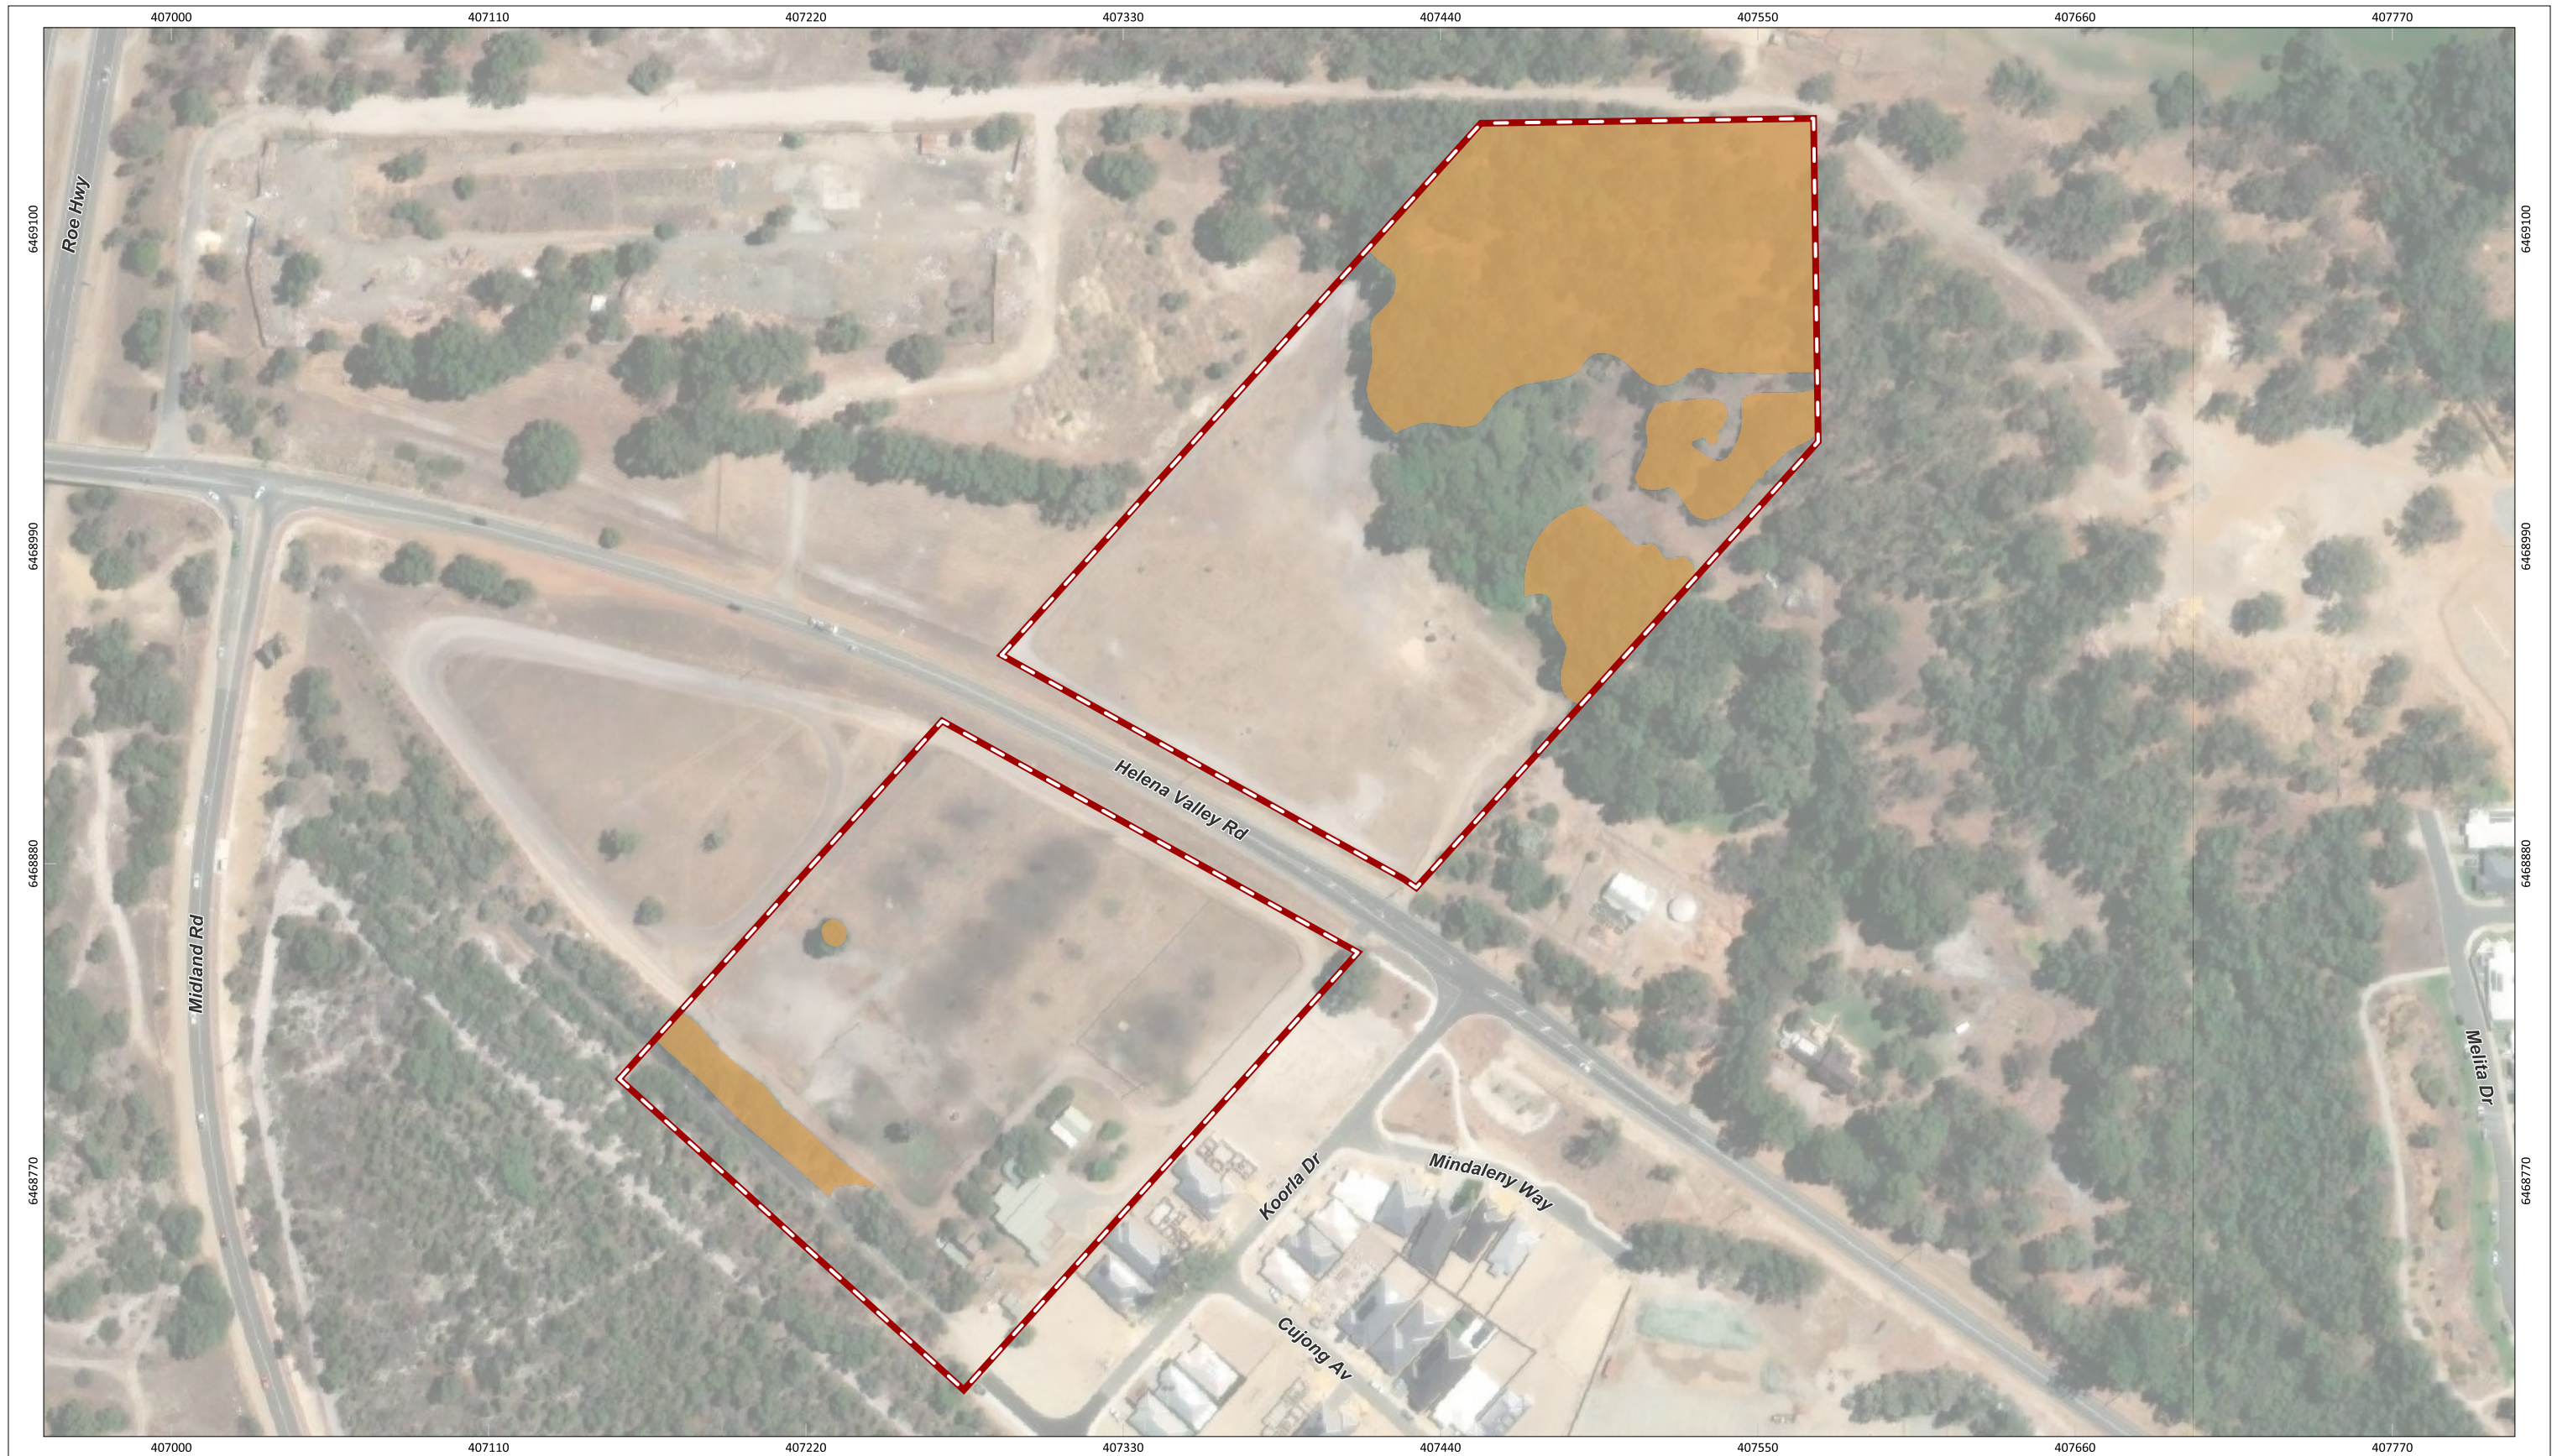
Figure 16: Potential Black Cockatoo Foraging Habitat

PGV (2022) identified a total of 0.3156 ha of cockatoo foraging habitat within the Survey Area, presenting two small polygons within the Site (see Appendix C - Figure 5). Upon review of the data and shapefiles provided, there was 1.84 ha within the Site (Figure 16).

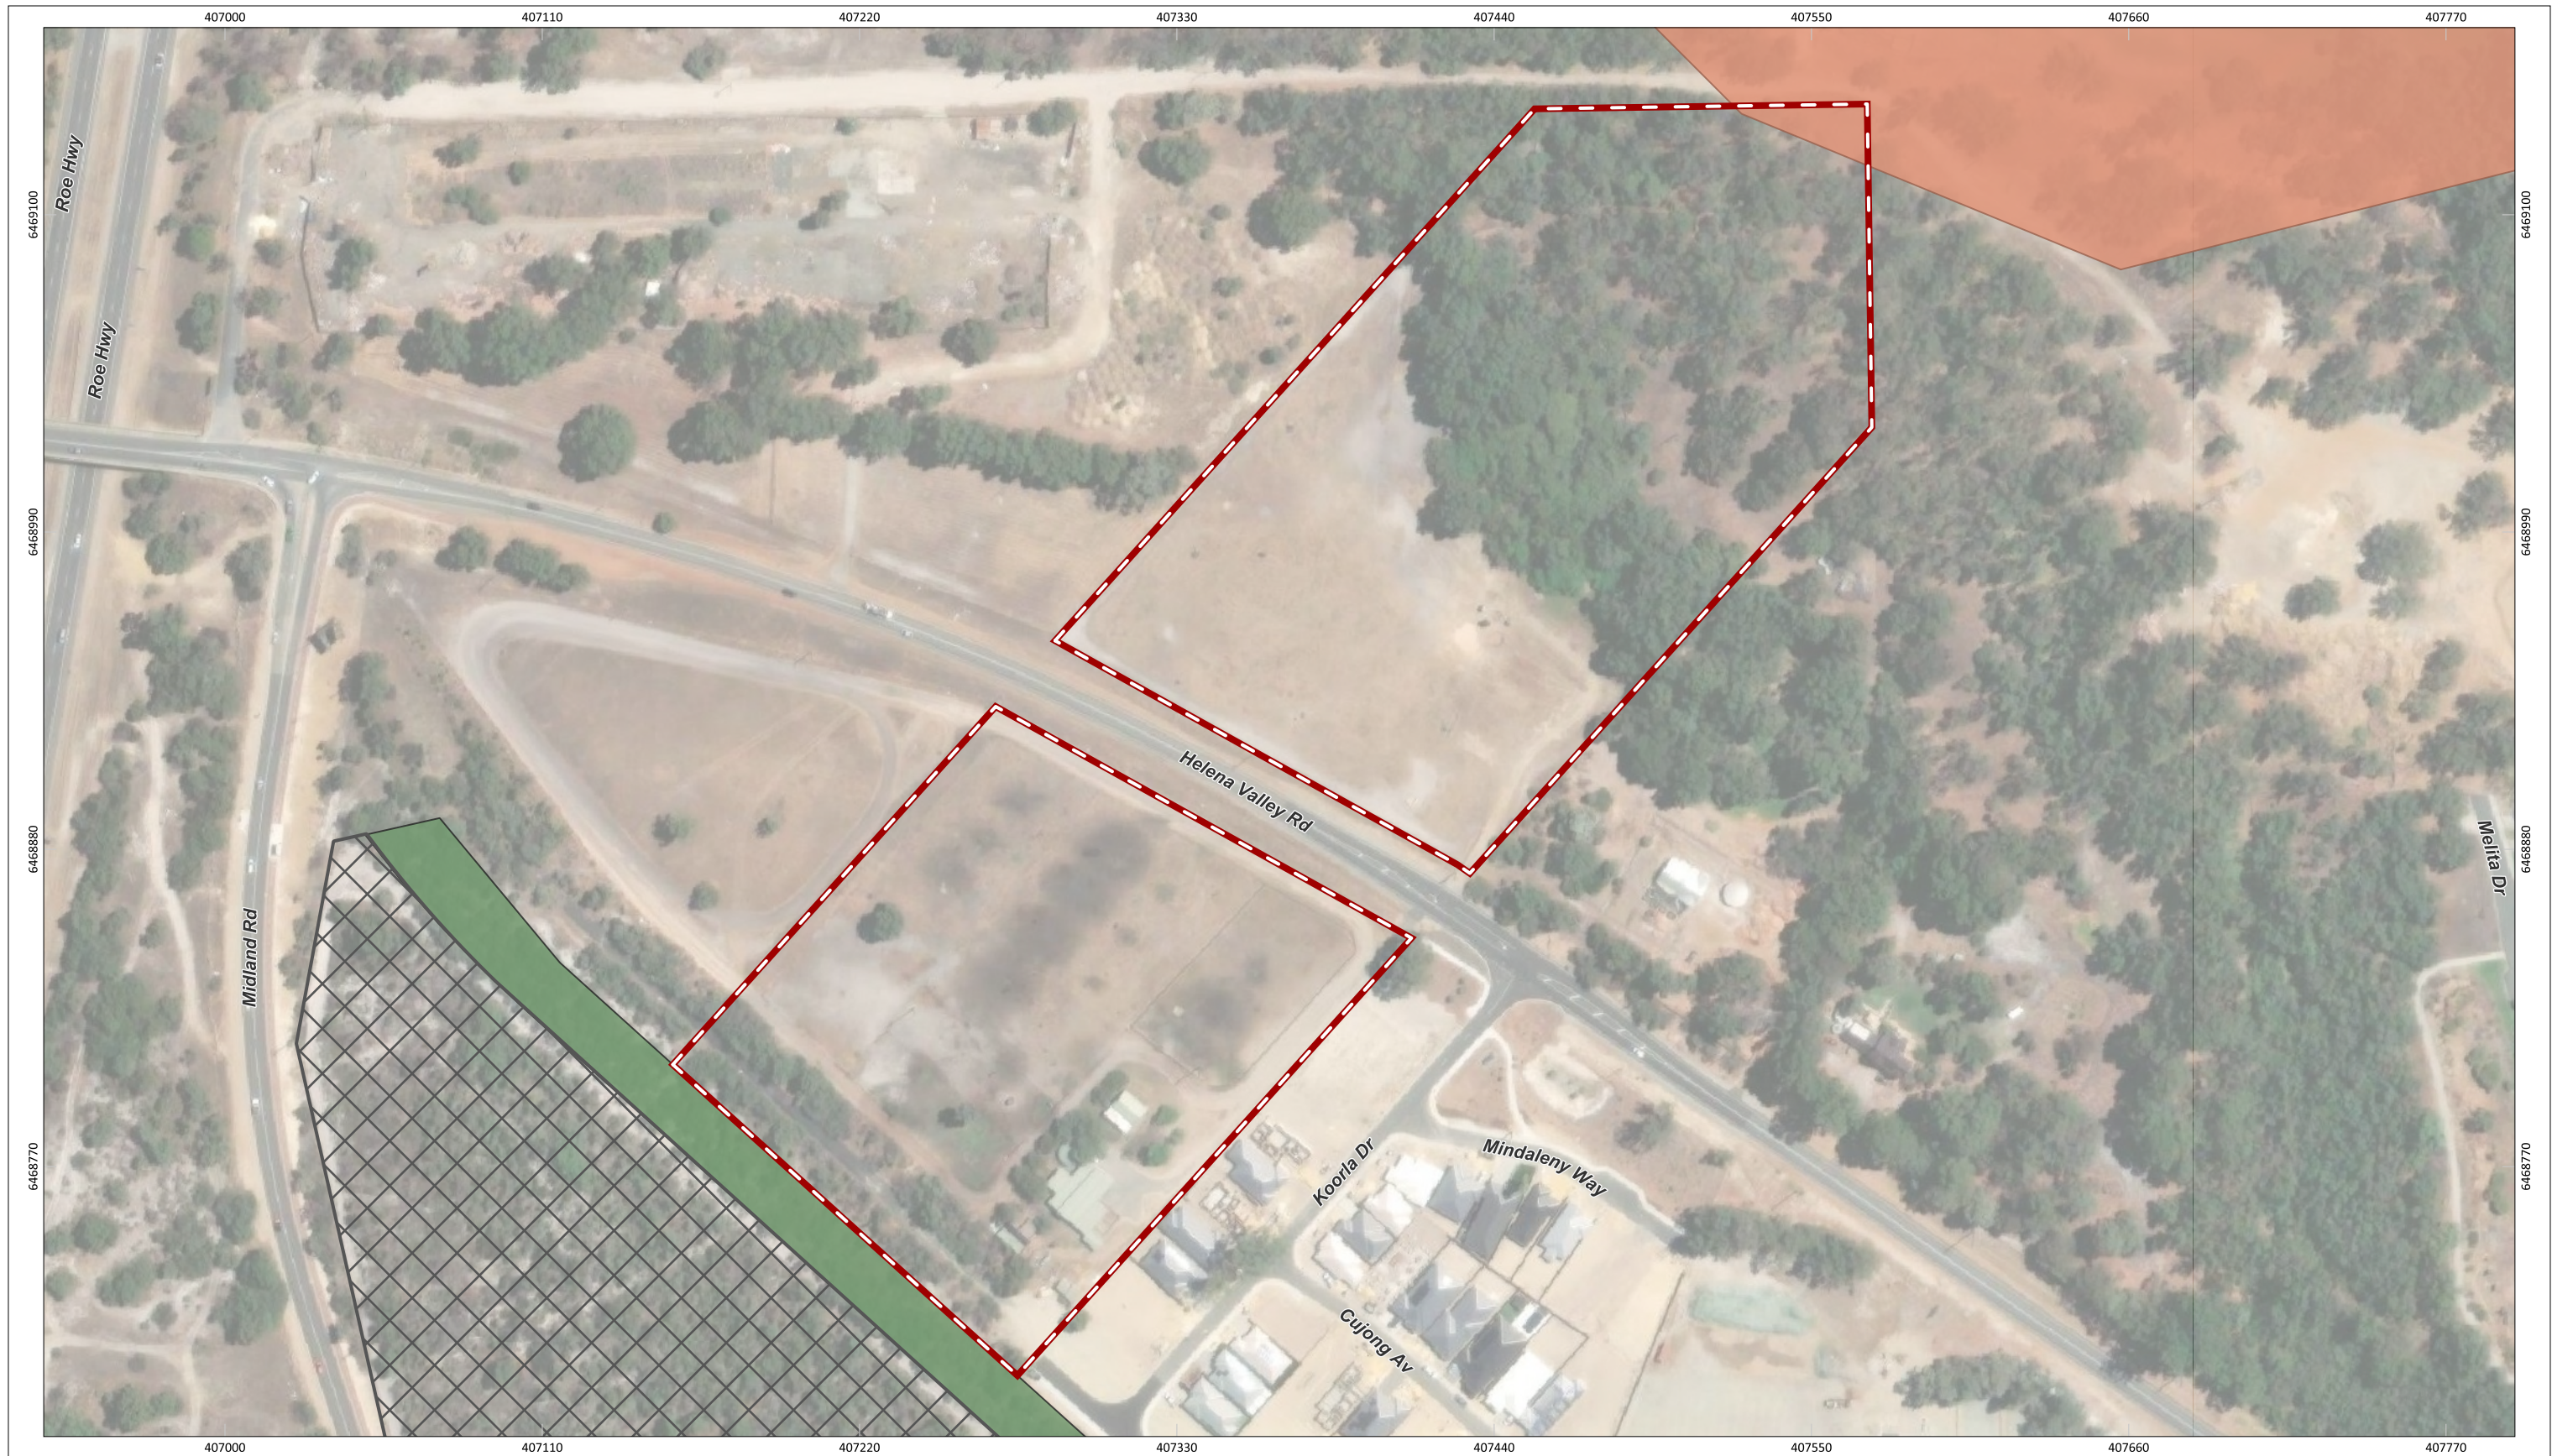
Figure 19: Conservation Areas

The northern corner of the intersects the 1976-1991 EPA Redbook Recommended Conservations Reserve recommendation M33 - The Darling System (DBCA-029). This area of the Site is not proposed to be impacted, and will be retained within the POS and CCW buffer (Figure 19).

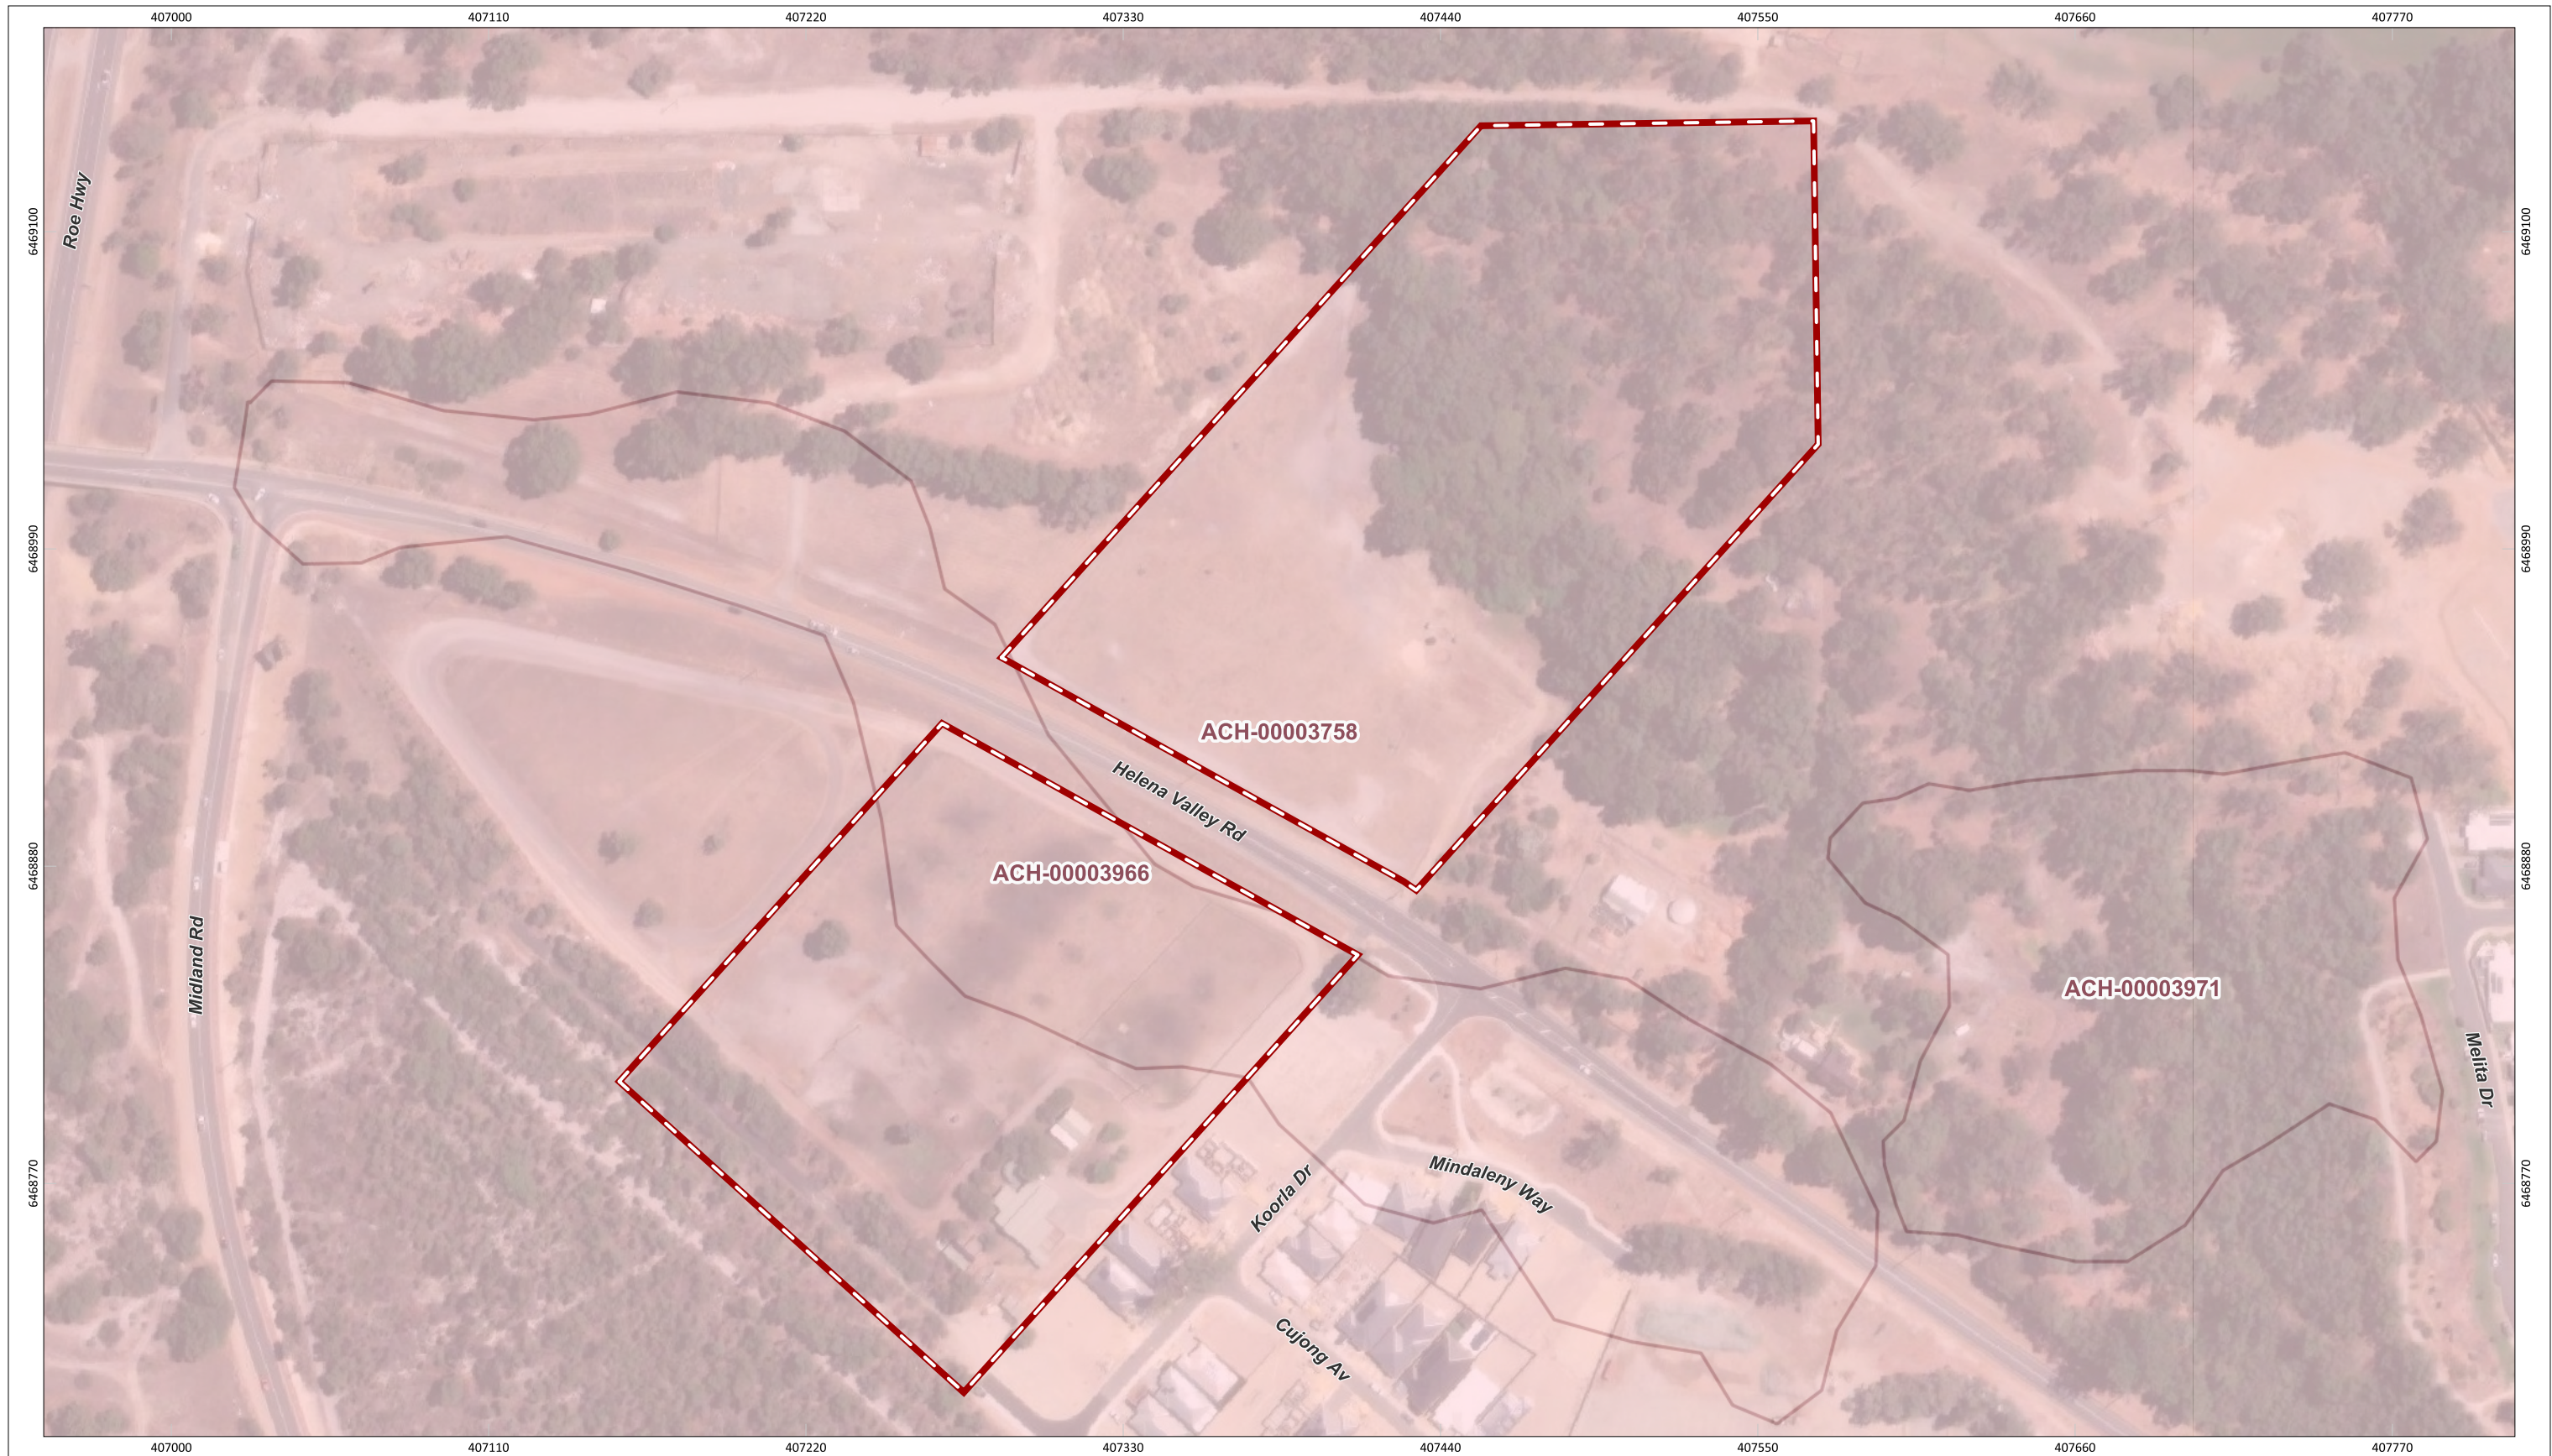
Figure 21: Aboriginal Heritage Site

A search of the Aboriginal Cultural Heritage Inquiry System (ACHIS) identified there are two registered Aboriginal Cultural Heritage (ACH) places mapped within the Site (DPLH-099) (PGV, 2023). These are summarised below in Table 3-18 and shown in Figure 21.
